SUBMITTED TO  
**WINDHAM COUNTY REGIONAL  
COMMISSION**

SUBMITTED BY  
**MSK ENGINEERS**

SCOPING STUDY

# **Jacksonville Municipal Center Access and Flood Resiliency**

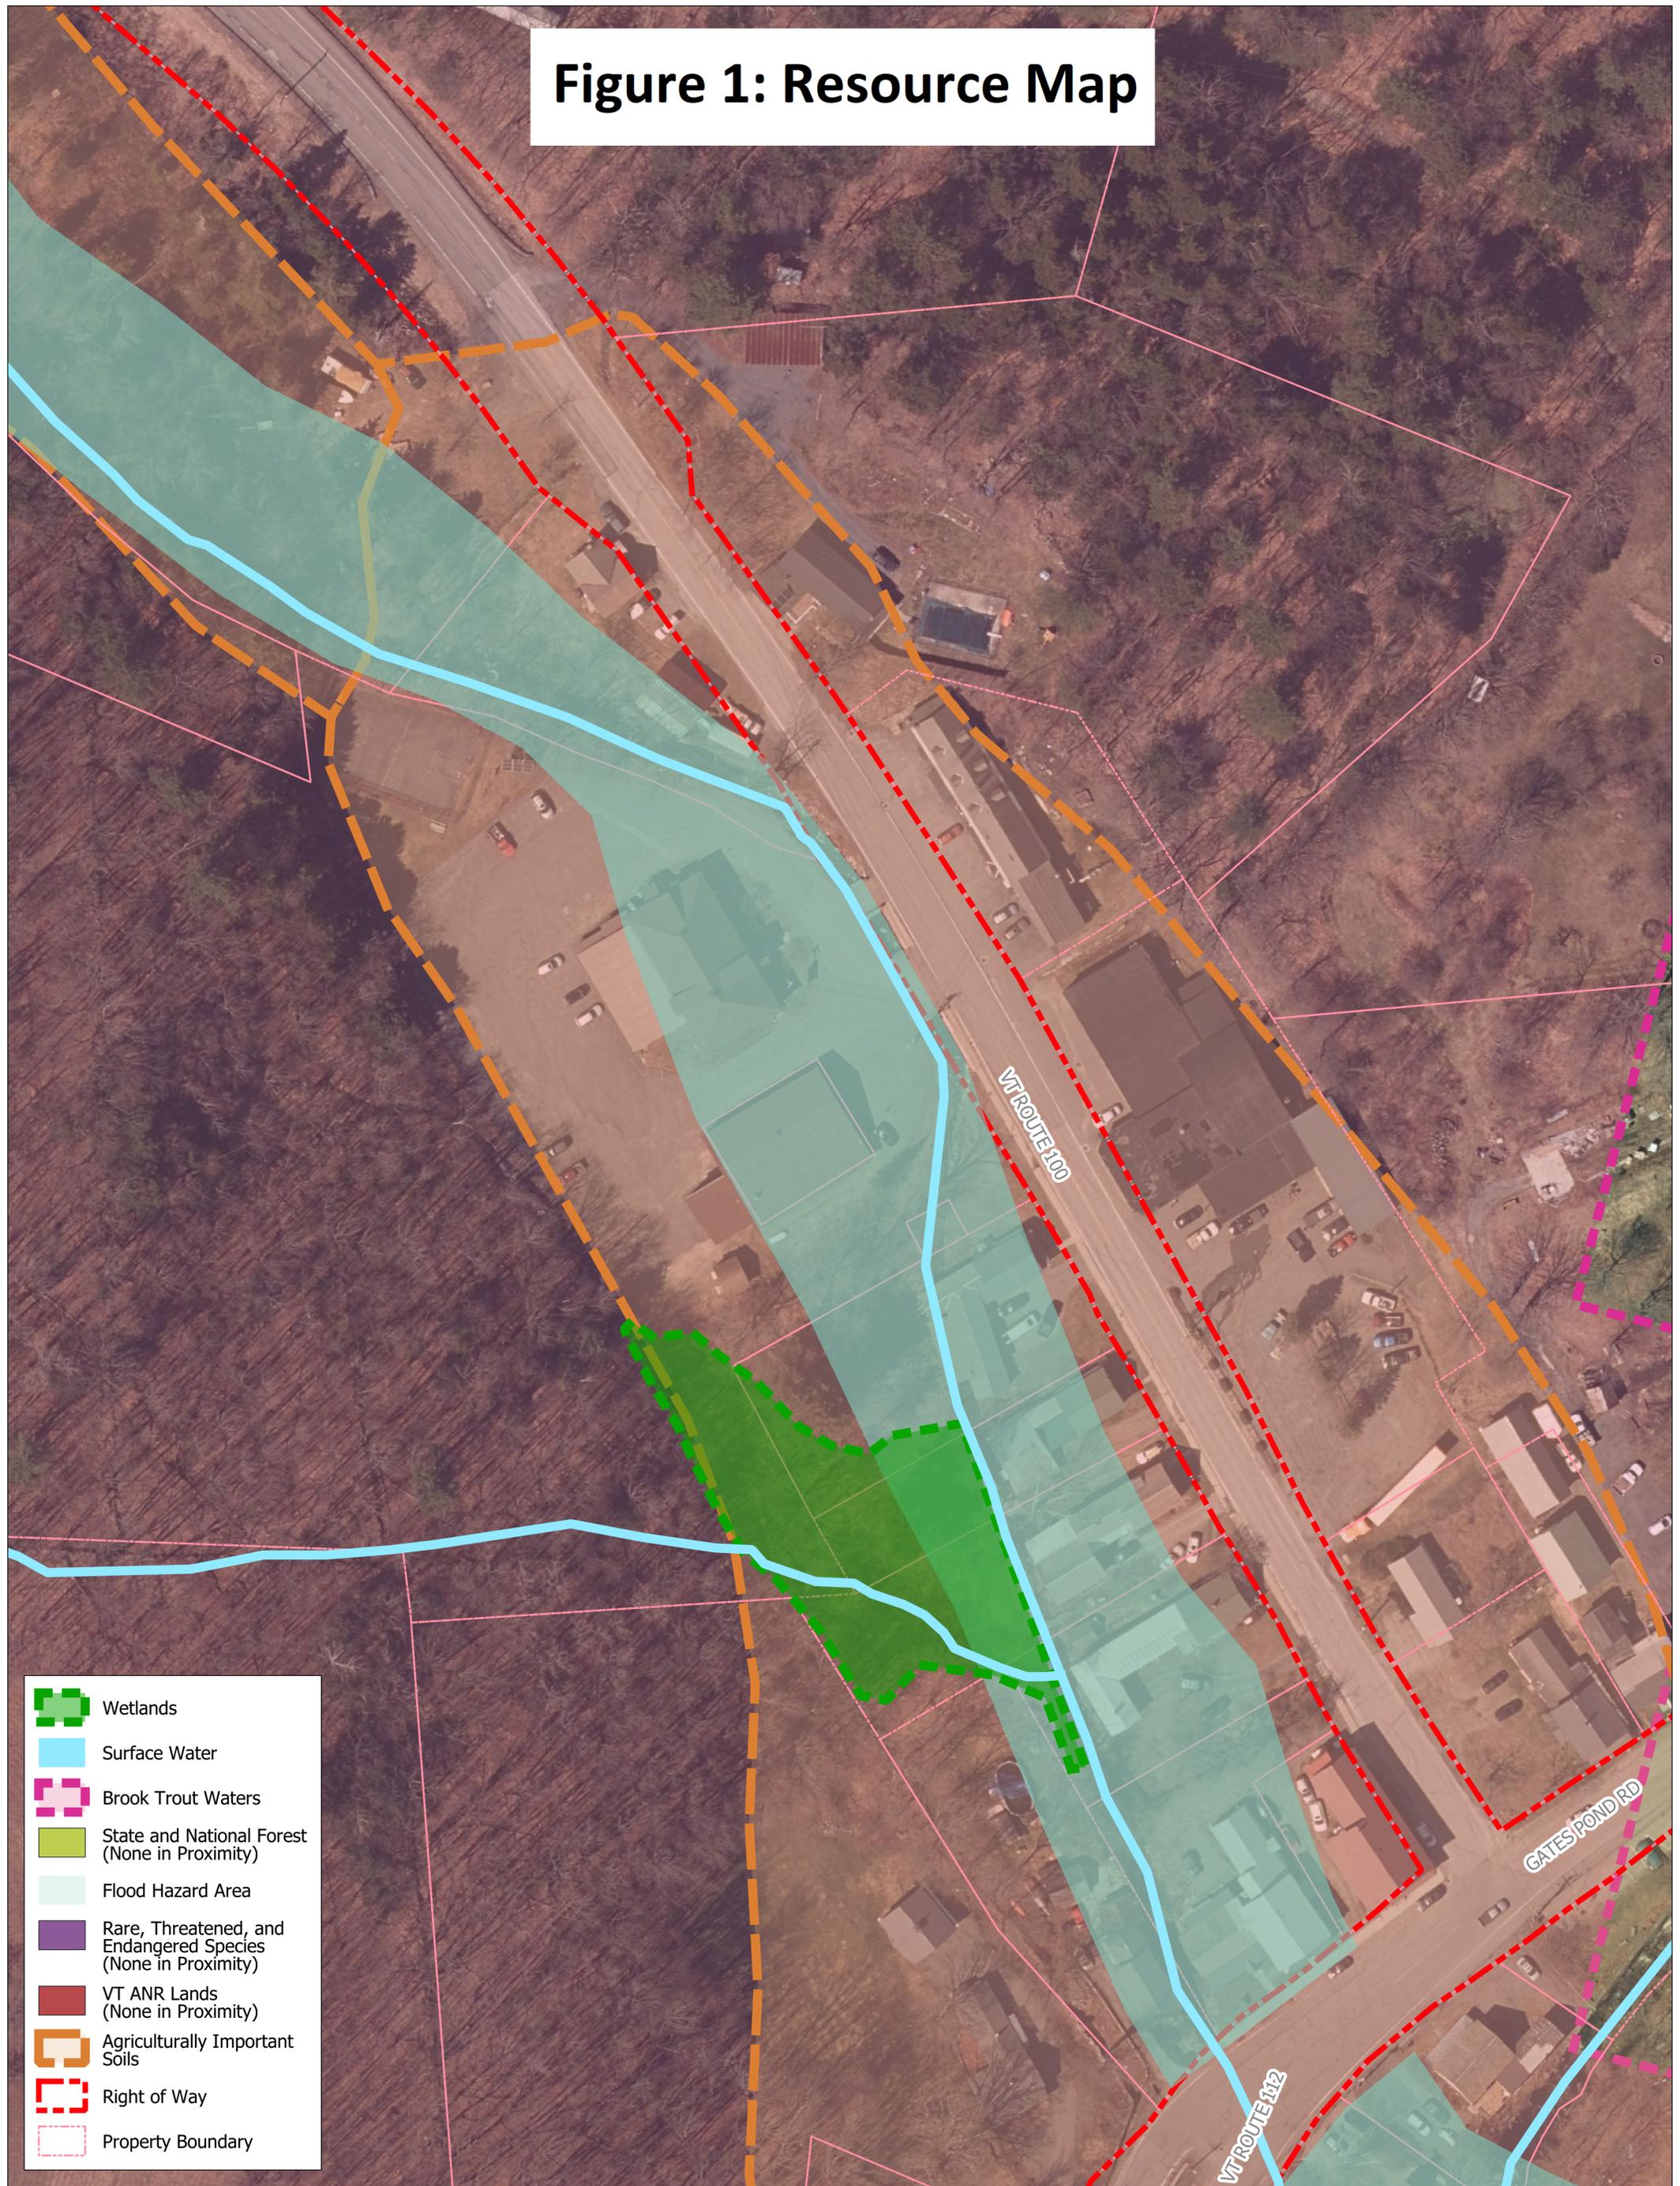
# Figure 1: Resource Map

Resources identified in the immediate project area include:

- 1) **Wetlands:** An approximately 0.5-acre forested floodplain wetland is located on the west side of the channel immediately downstream of the fire station. Under the existing site condition, the wetland receives sheetflow runoff from the steep forested slope to the west and receives overflow from the river during larger flood events. The proposed channel improvements will have no direct impacts on the wetland or associated buffers. Installation of a bankfull structure will improve conveyance during large flood events, likely increasing the volume of water accessing the floodplain wetland.

- 2) **Flora/Fauna Including Brook Trout:** The bottom of the existing culvert is rusted out. During baseflow conditions all water flows through the bottom of the culvert. The existing culvert condition is likely a barrier to brook trout movement, particularly during low flows. The undersized culvert may also reduce Brook Trout movement during elevated flows due to high velocity. Replacing the existing culvert with a bankfull structure, designed to maintain a naturalized bottom, will significantly improve Brook Trout passage during low flows and will reduce velocity during elevated flow conditions. During the design phase aquatic organism passage should be evaluated as part of the permitting effort.

- 4) **Flood Hazards:** The forested floodplain area described above represents the only accessible floodplain area between the project site and the confluence with Gates Pond Brook downstream of the VT 100/112 crossing. The proposed channel improvements do not directly affect floodplain accessibility or function, however the installation of a bankfull structure will increase channel capacity and conveyance during large storm events. Historically, large flood events exceeded the capacity of the existing culvert causing floodwater to spill over onto VT 100. The widened river will protect municipal assets like municipal center/firehouse.

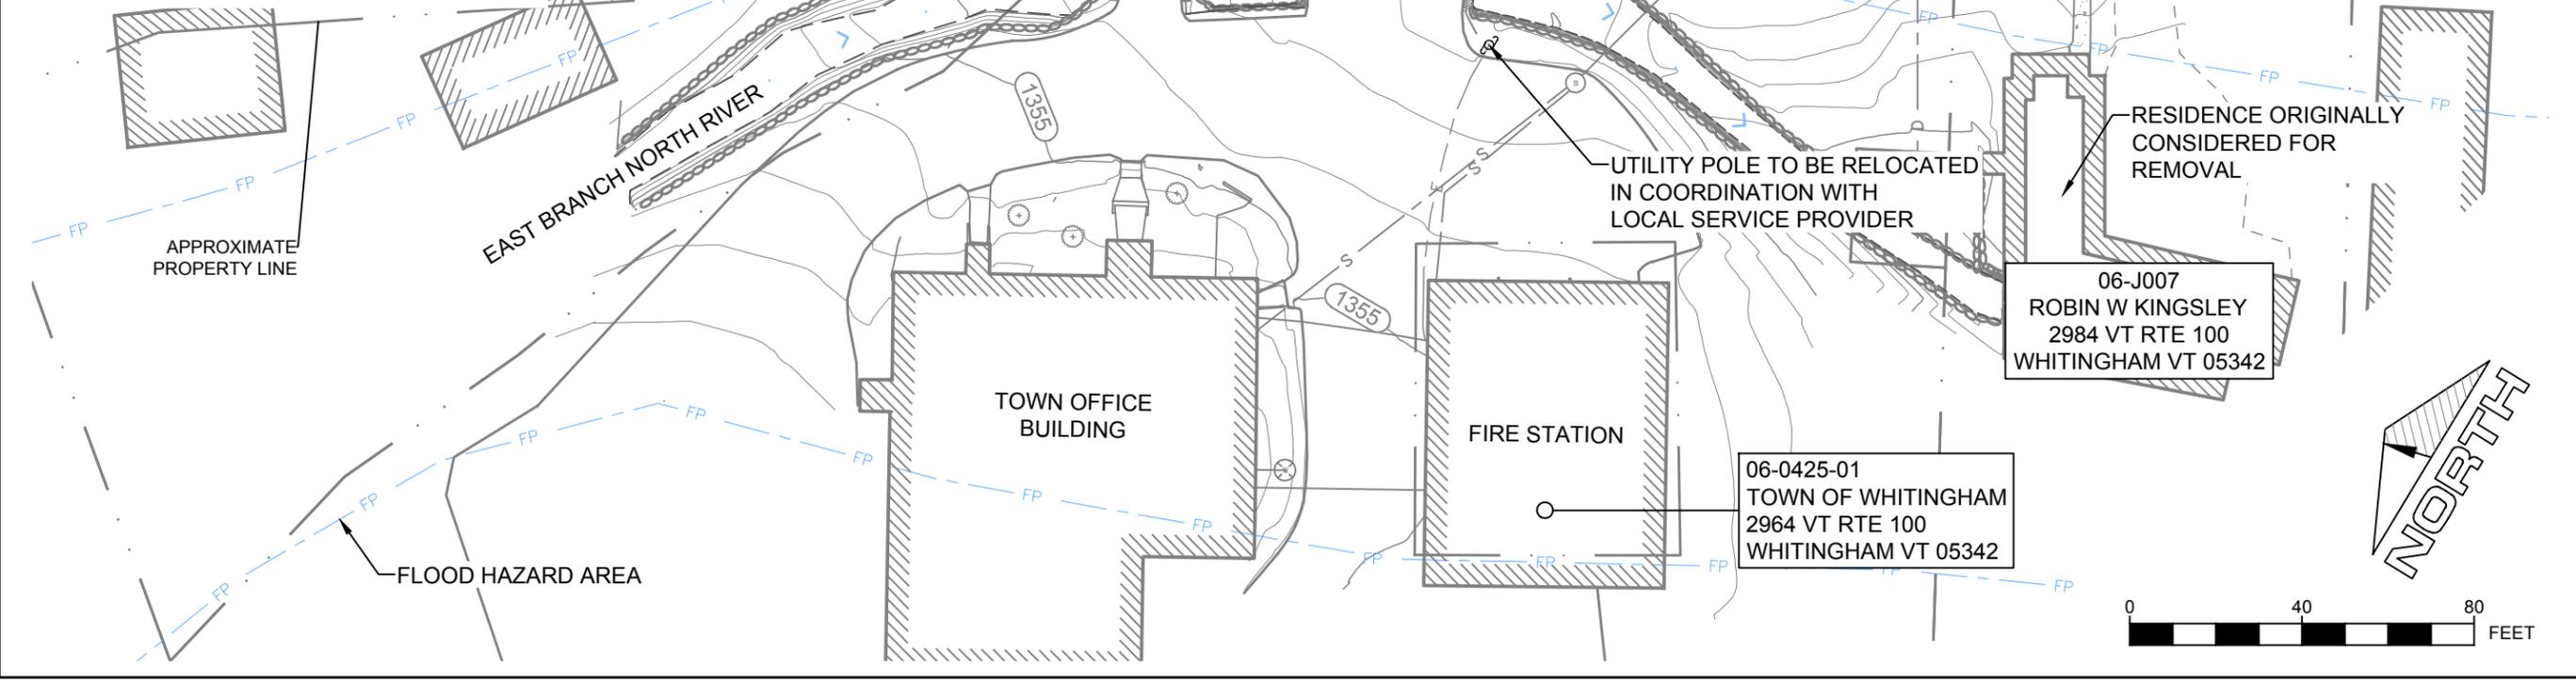
**Figure 2: Existing Conditions**

EXISTING CONDITIONS PLAN

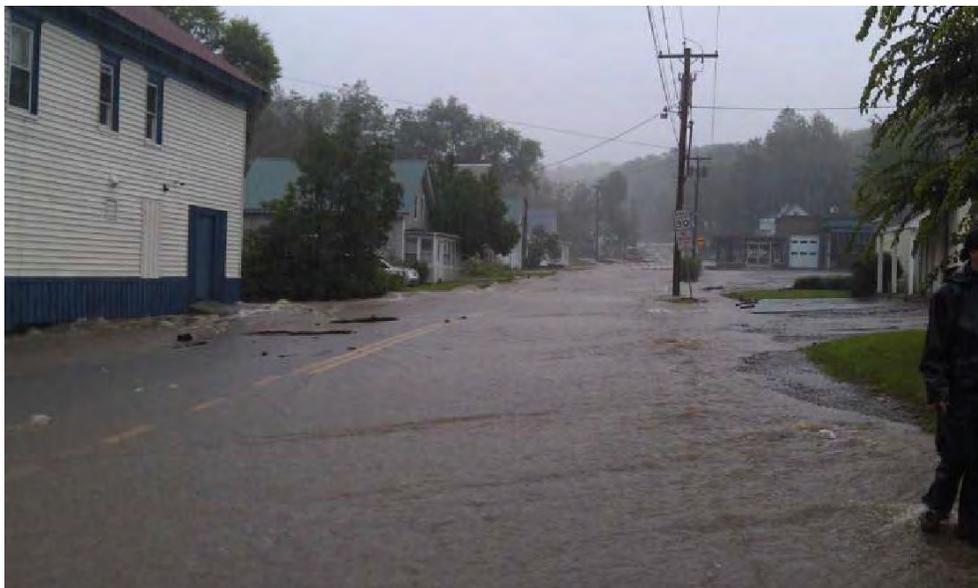
Figure 3: August 2011 flooding on VT 100 in Jacksonville during the Irene flood.

This alternative would be to leave the site as it is. This would not improve the downtown flood resiliency and leave the downtown at risk of flooding during storm events. Hydraulic modeling indicates that the undersized crossings at the municipal center, in particular the severely undersized bridge, cause floodwaters to overtop the road by 1-2 feet during an extreme flood event (i.e., 100-year flood). When the effect of sediment and debris buildup during a flood is considered at the bridge inlet, which has been commonplace in past floods, moderate floods such as the 25-year or 50-year floods are predicted to overtop the road and flow down VT 100. The no build alternative leaves the town's infrastructure and several other private residences and businesses along VT 100 at risk of repeat flood damage.

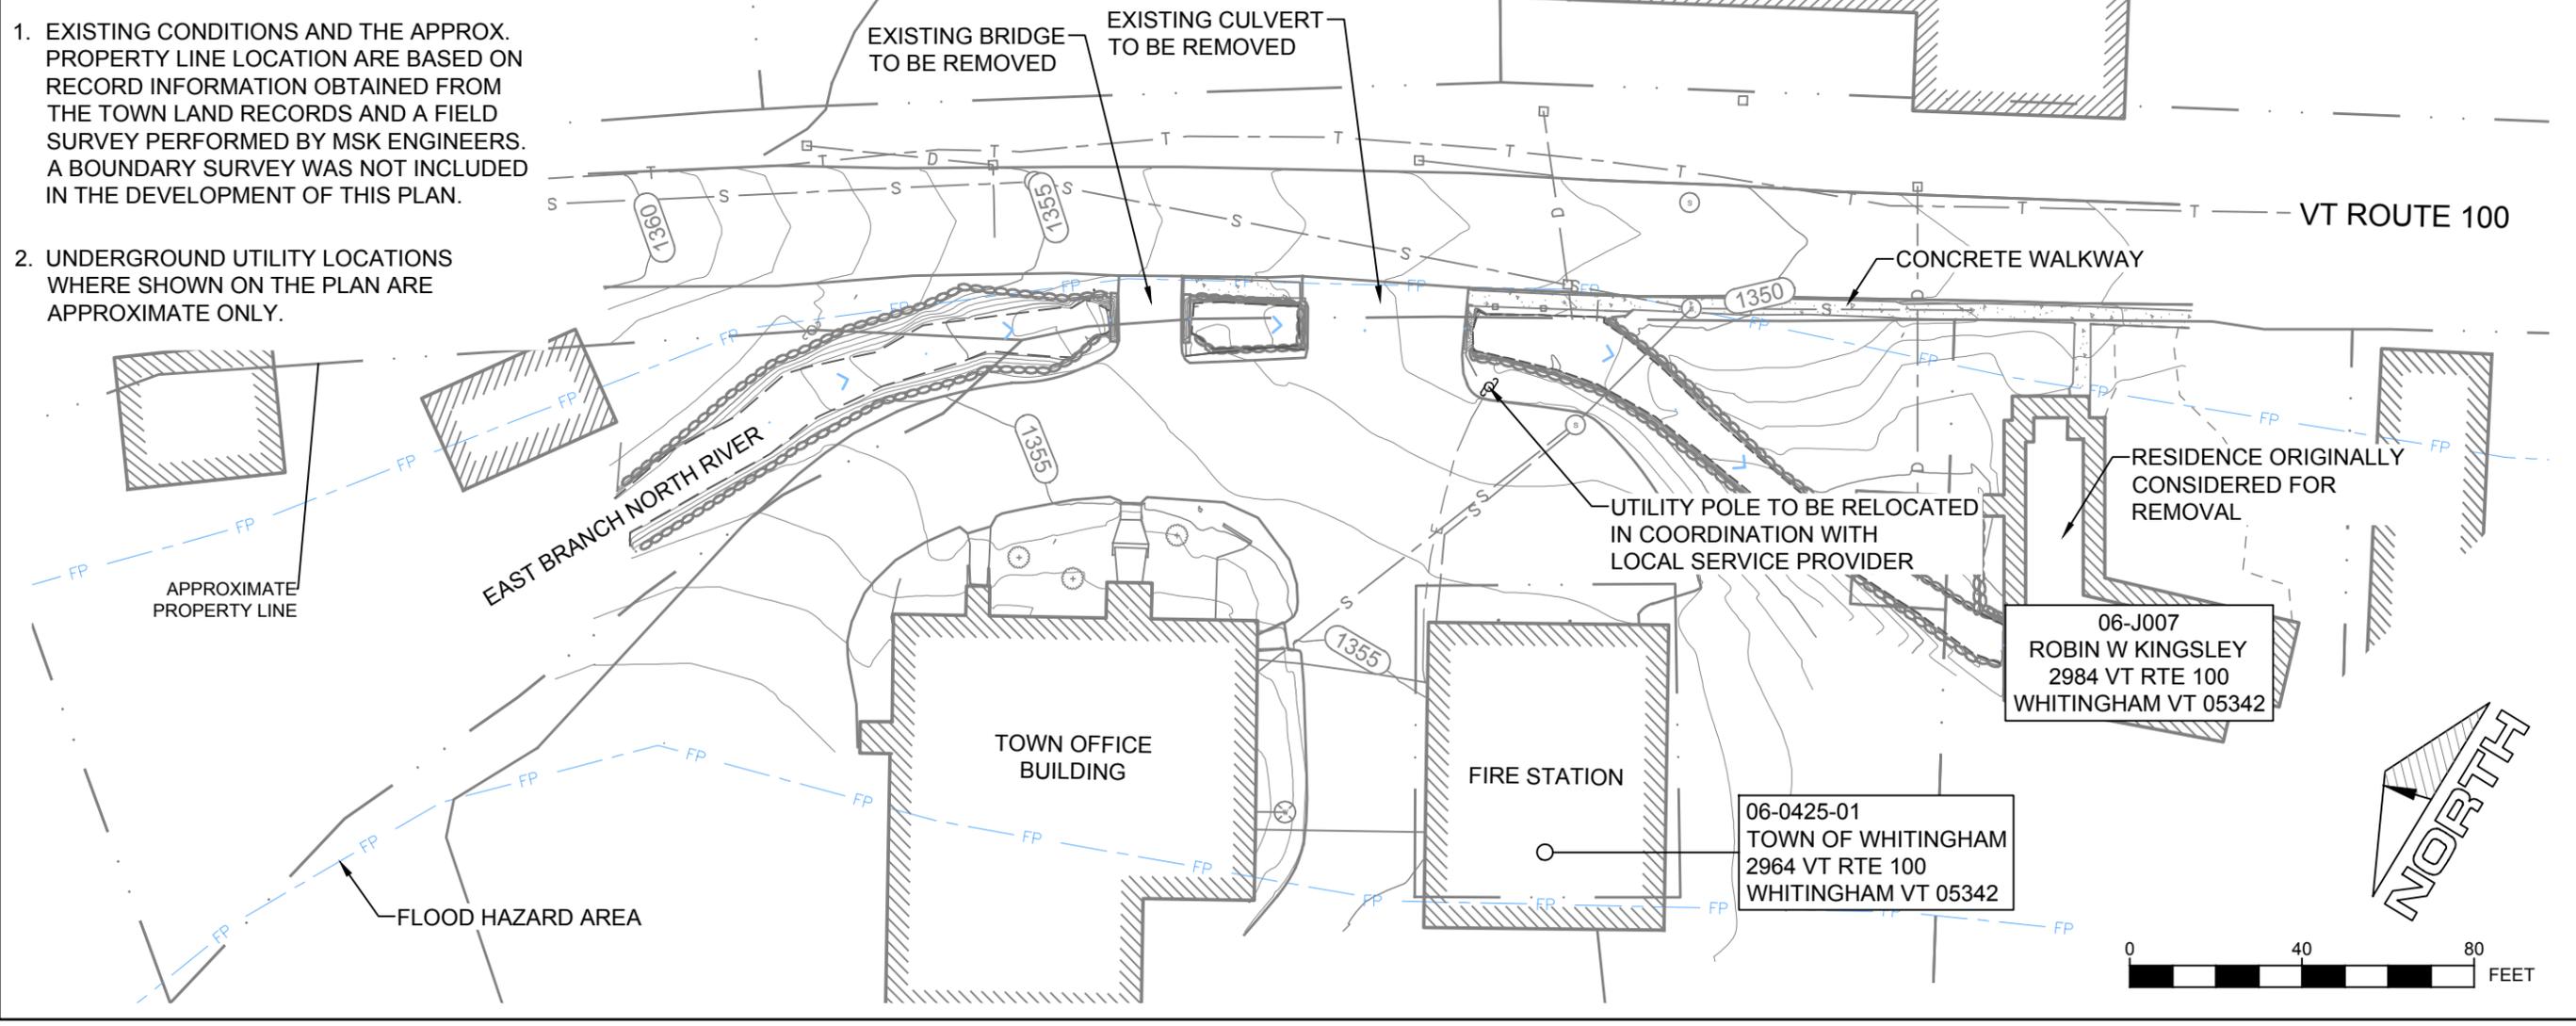
EXISTING CONDITIONS / NO BUILD PLAN

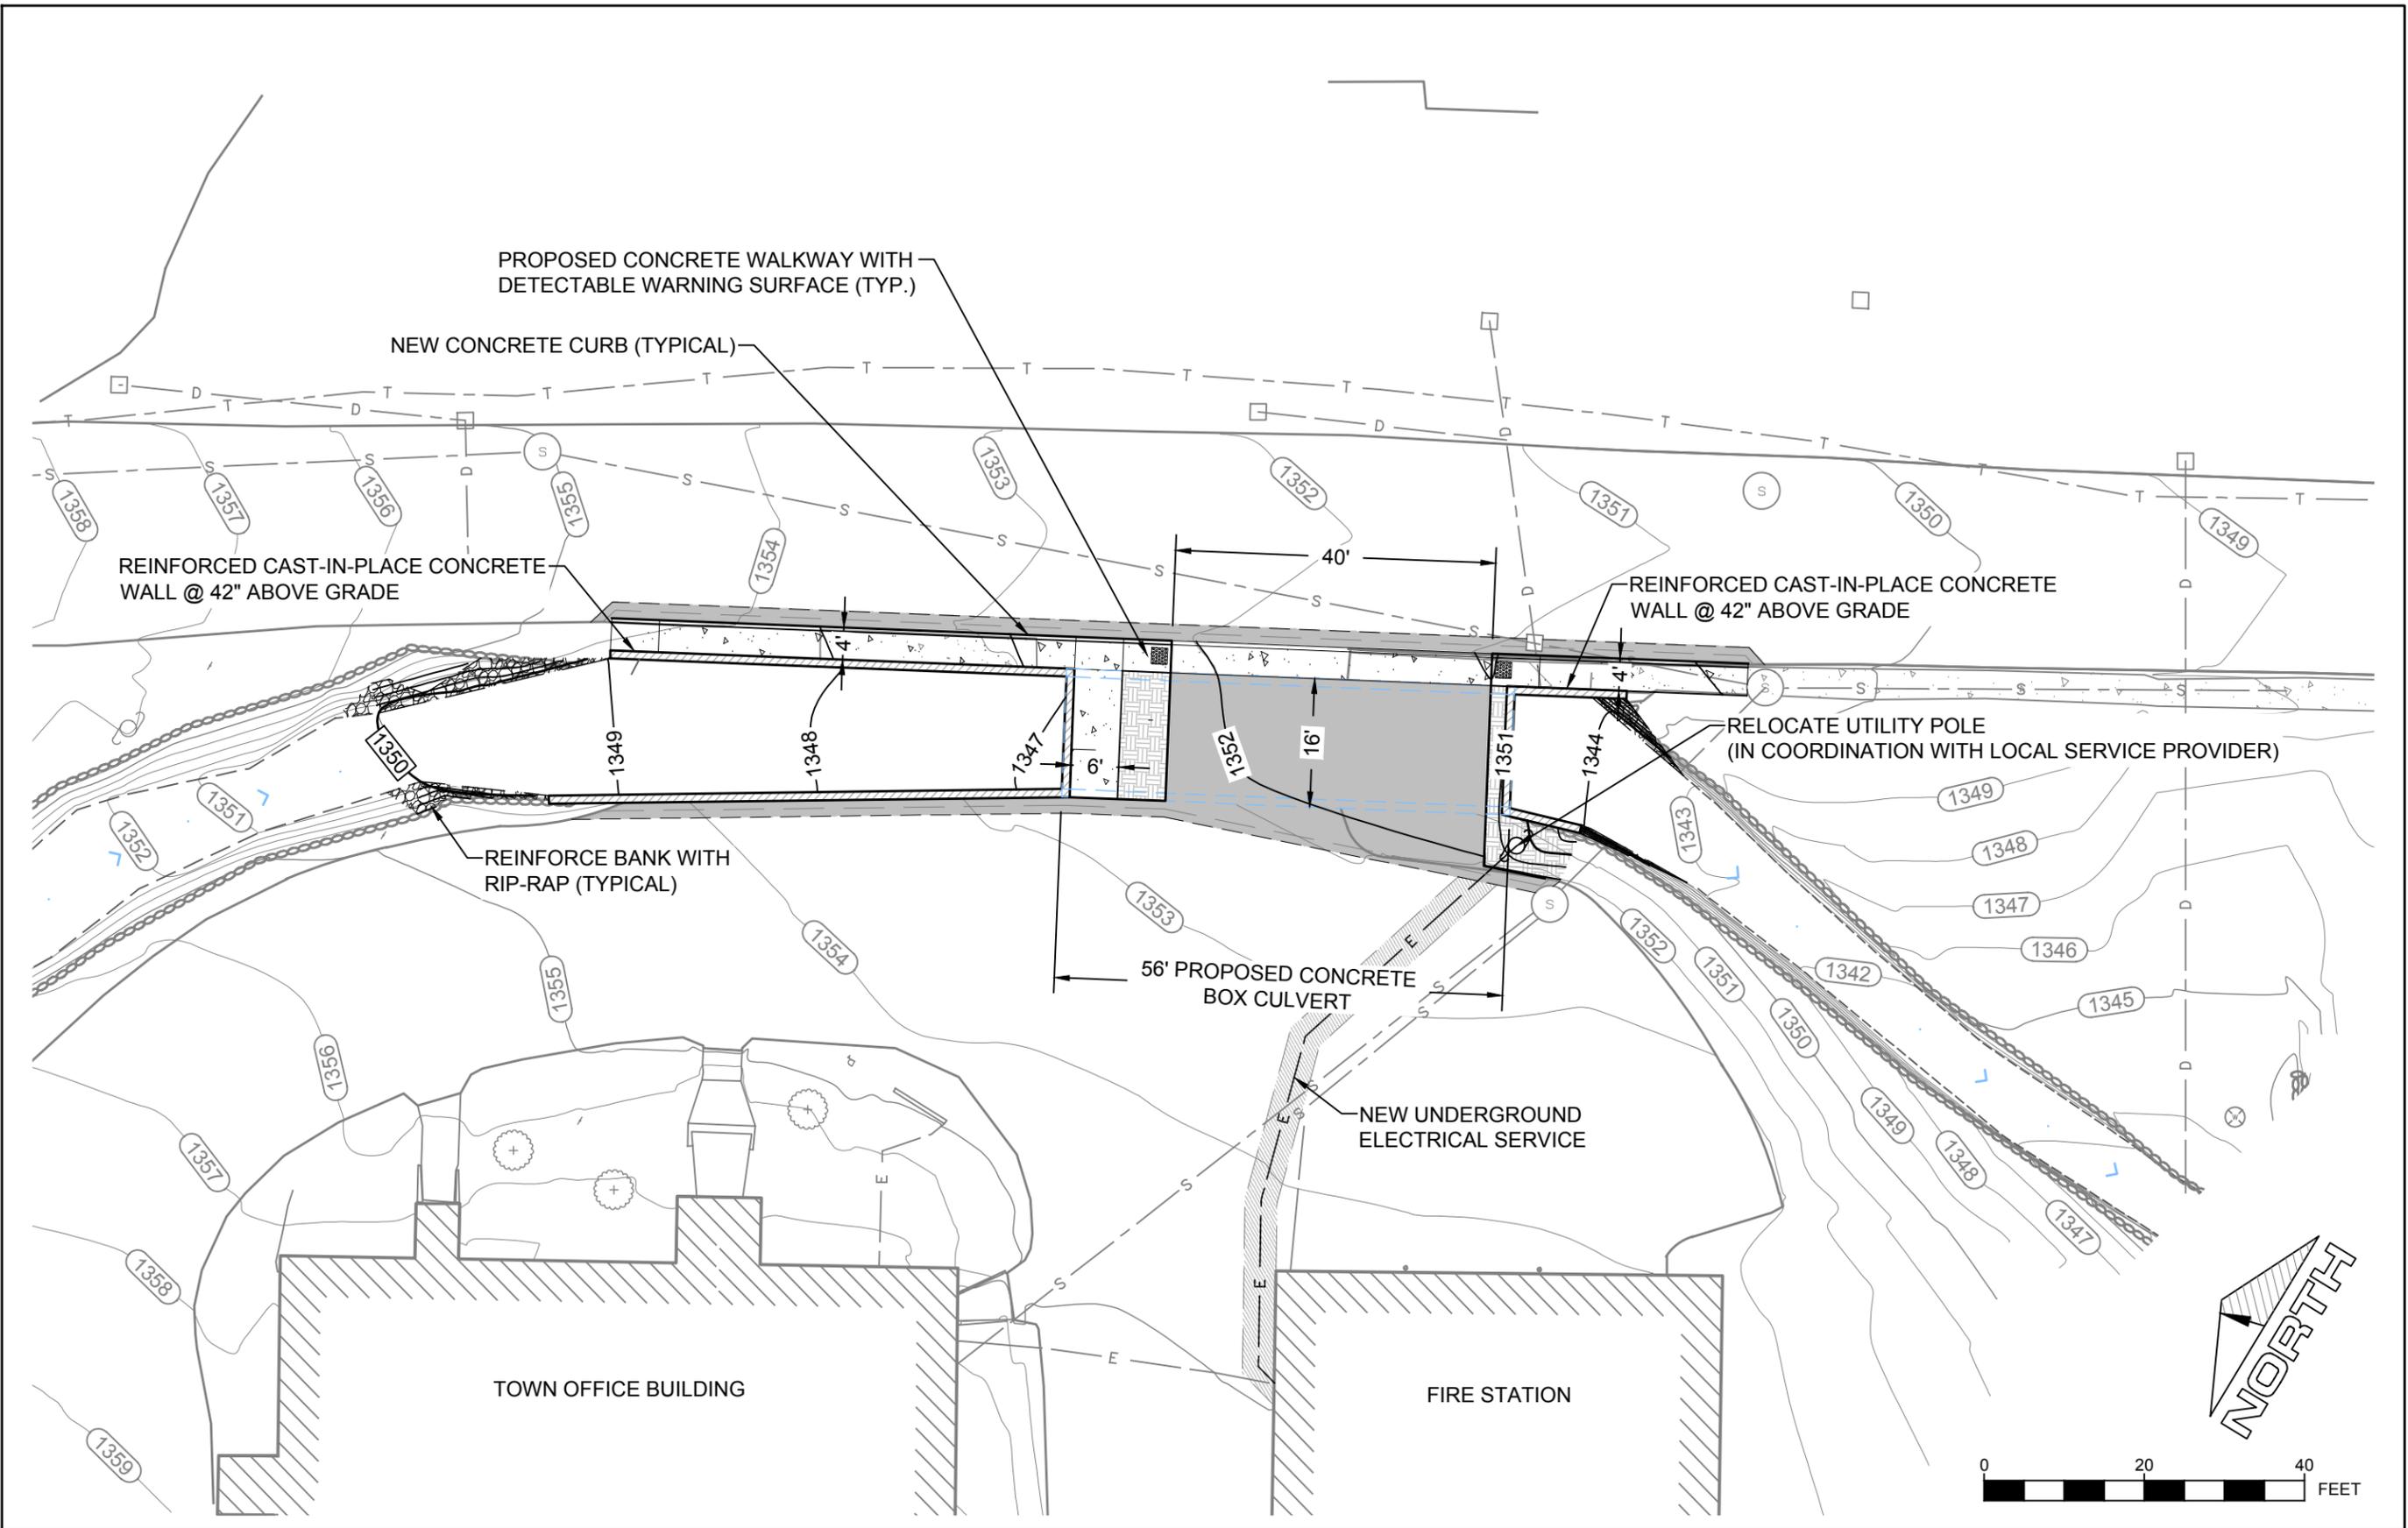
**Figure 5: Alternative 2 | 56' Long by 16' Wide Culvert**

**PRELIMINARY**  
**NOT FOR CONSTRUCTION**  
 PROPOSED CONDITIONS PLAN  
 ALTERNATIVE 2

This alternative would involve the demolition of the existing concrete bridge and replacement of the existing undersized culvert with a bankfull sized culvert and widening and stabilizing the river channel in front of the municipal complex. This would improve the downtown flood resiliency and reduce the risk of flooding during storm events. The available parking on site would be reduced in this scenario as the channel widening would require the reduction of several parking spaces along the river.

Hydraulic modeling indicates that the proposed bankfull sized structure would lower floodwaters substantially at the Municipal Center and significantly reduce the risk of flooding along VT 100. Specifically, floodwater elevations at the municipal center are predicted to be 3-4 feet lower during an extreme flood event (i.e., 100-year flood) in comparison to the existing condition. There would also be significant improvements during moderate floods (i.e., 25-year or 50-year floods) as there would be 3-4 feet of the total bridge height remaining to accommodate sediment and debris buildup at the inlet. In other words, the proposed culvert replacement would be resilient to most or all extreme flood conditions anticipated in this setting. In addition, the new crossing structure would have a naturalized bottom allowing for full aquatic organism passage.

It is important to note that the flood conveyance improvements associated with Alternatives 2 and 3 are limited to the municipal property in the vicinity of the fire station. This is because severe channel constrictions will remain downstream, including the undersized channel on municipal property and the building overhanging the river channel on the adjacent property to the south.

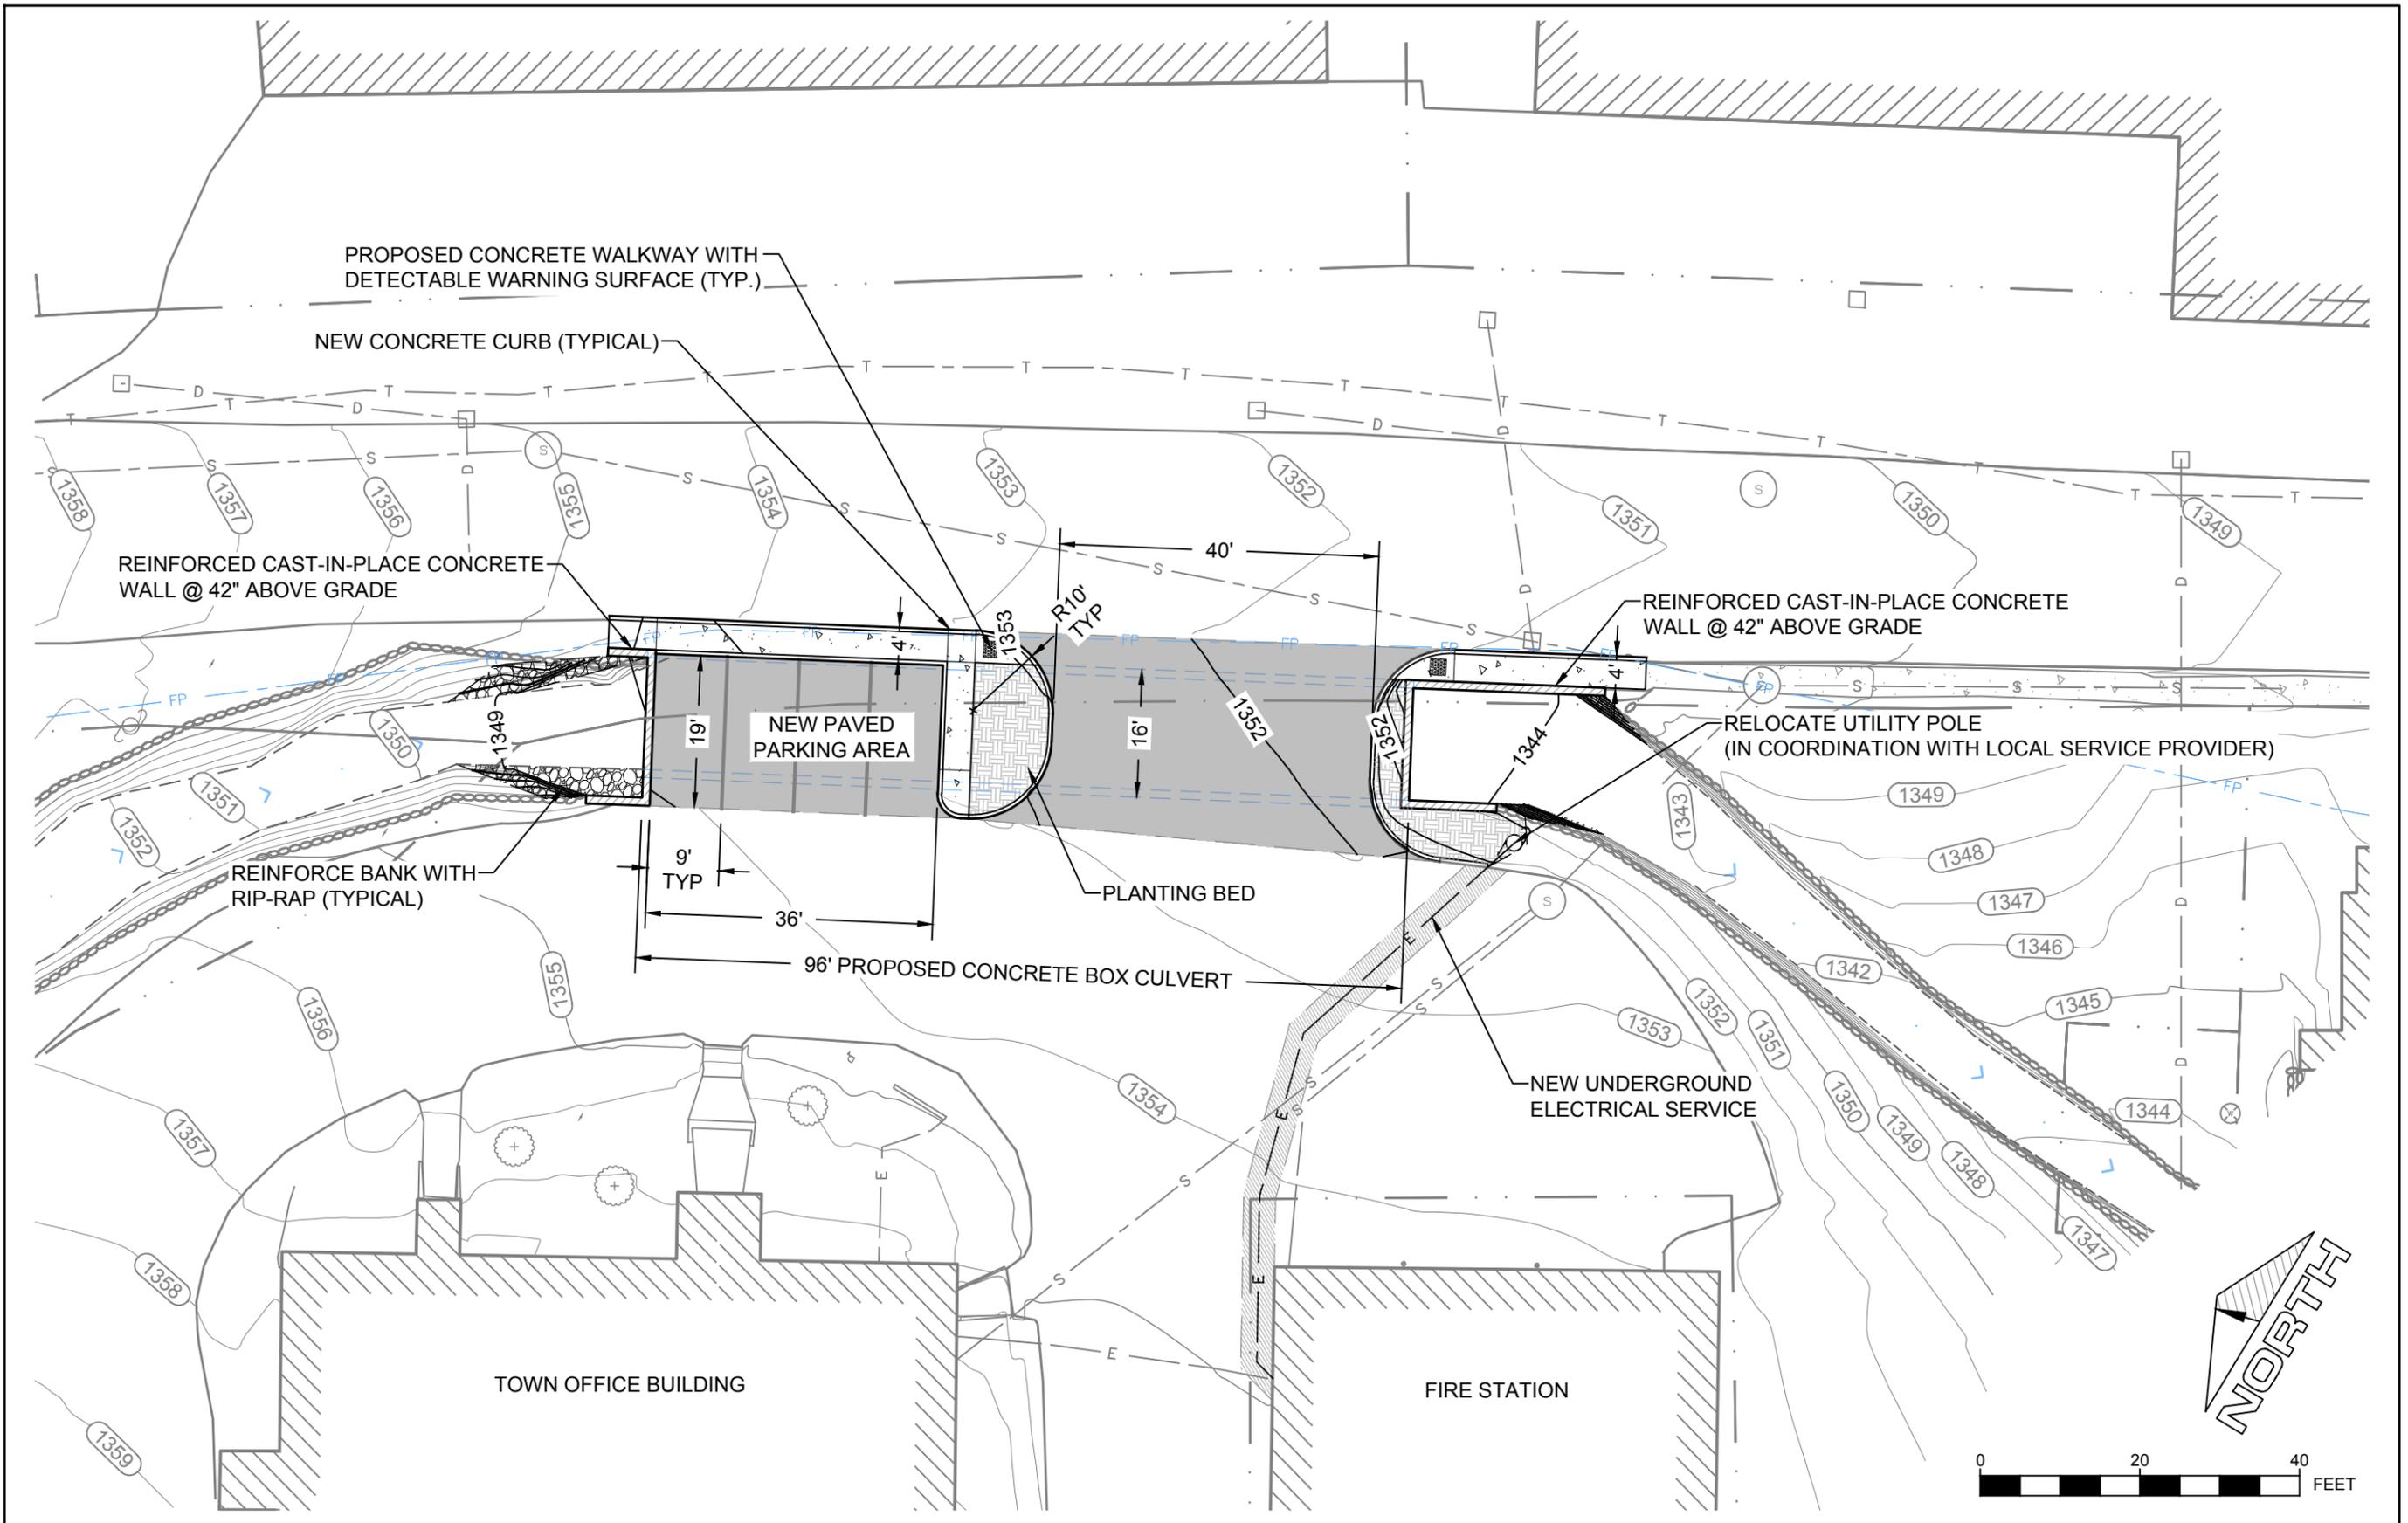
**Figure 6: Alternative 3 | 96' Long by 16' Wide Culvert**

**PRELIMINARY**  
**NOT FOR CONSTRUCTION**  
 PROPOSED CONDITIONS PLAN  
 ALTERNATIVE 3

This alternative would involve the demolition of the existing concrete bridge and the replacement of a culvert and widening and stabilizing the river channel in front of the municipal complex. This would improve the downtown flood resiliency and reduce the risk of flooding during storm events. The available parking on site would remain in this scenario as the culvert would extend further upstream allowing for parking to be reconfigured in front of the municipal complex.

Regarding flood resiliency, Alternative 3 would not result in significant improvements over Alternative 2. Hydraulic modeling indicates that the longer structure would only marginally increase floodwater conveyance during moderate and extreme flood conditions. Floodwater elevations at the Municipal Center are predicted to be less than 6" lower in Alternative 3 as compared to Alternative 2. This is because the gains in floodwater conveyance over the existing condition are a result of the increased hydraulic opening to 16 feet, which is the same in Alternatives 2 and 3.

It is important to note that the flood conveyance improvements associated with Alternatives 2 and 3 are limited to the municipal property in the vicinity of the fire station. This is because severe channel constrictions will remain downstream, including the undersized channel on municipal property and the building overhanging the river channel on the adjacent property to the south.

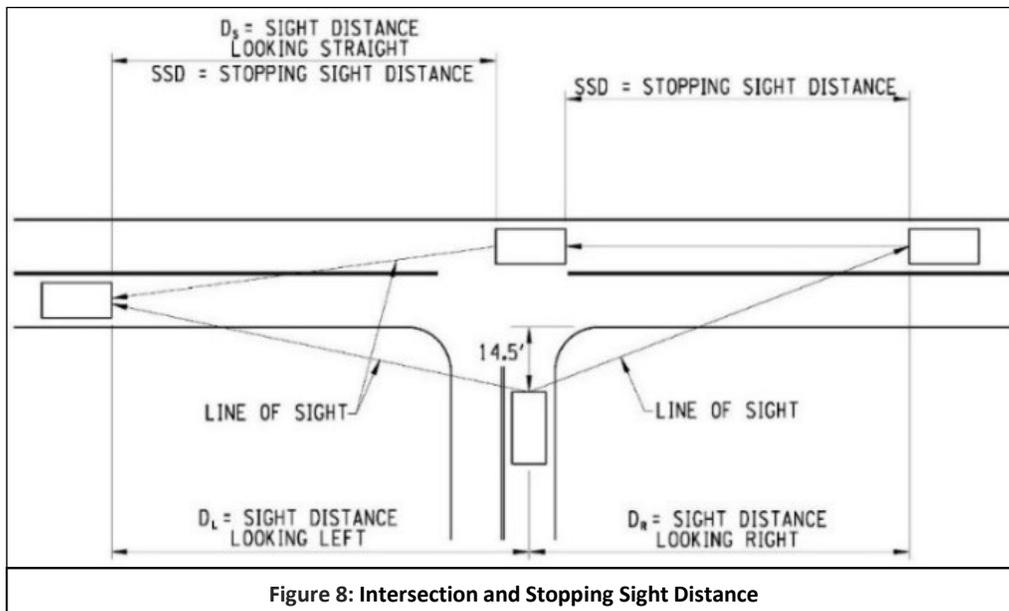
Figure 8: Intersection and Stopping Sight Distance

Travel speed data collected by Creighton Manning near the project site shows that the 85<sup>th</sup> percentile travel speed on VT 100 is approximately 41 mph. The sight distances measured in the field were compared to the guidelines presented in *A Policy on Geometric Design of Highways and Streets, 2018* published by the American Association of State Highway Transportation Officials (AASHTO) and the Vermont Agency of Transportation (VTrans) Traffic Impact Study Guidelines for the 41-mph design speed. The results of the evaluation are summarized in Table 1.

While the posted speed is 30-mph, the available intersection and stopping sight distances at the Site Access Road intersection on VT 100 meet the AASHTO guidelines for the observed 41-mph speed.

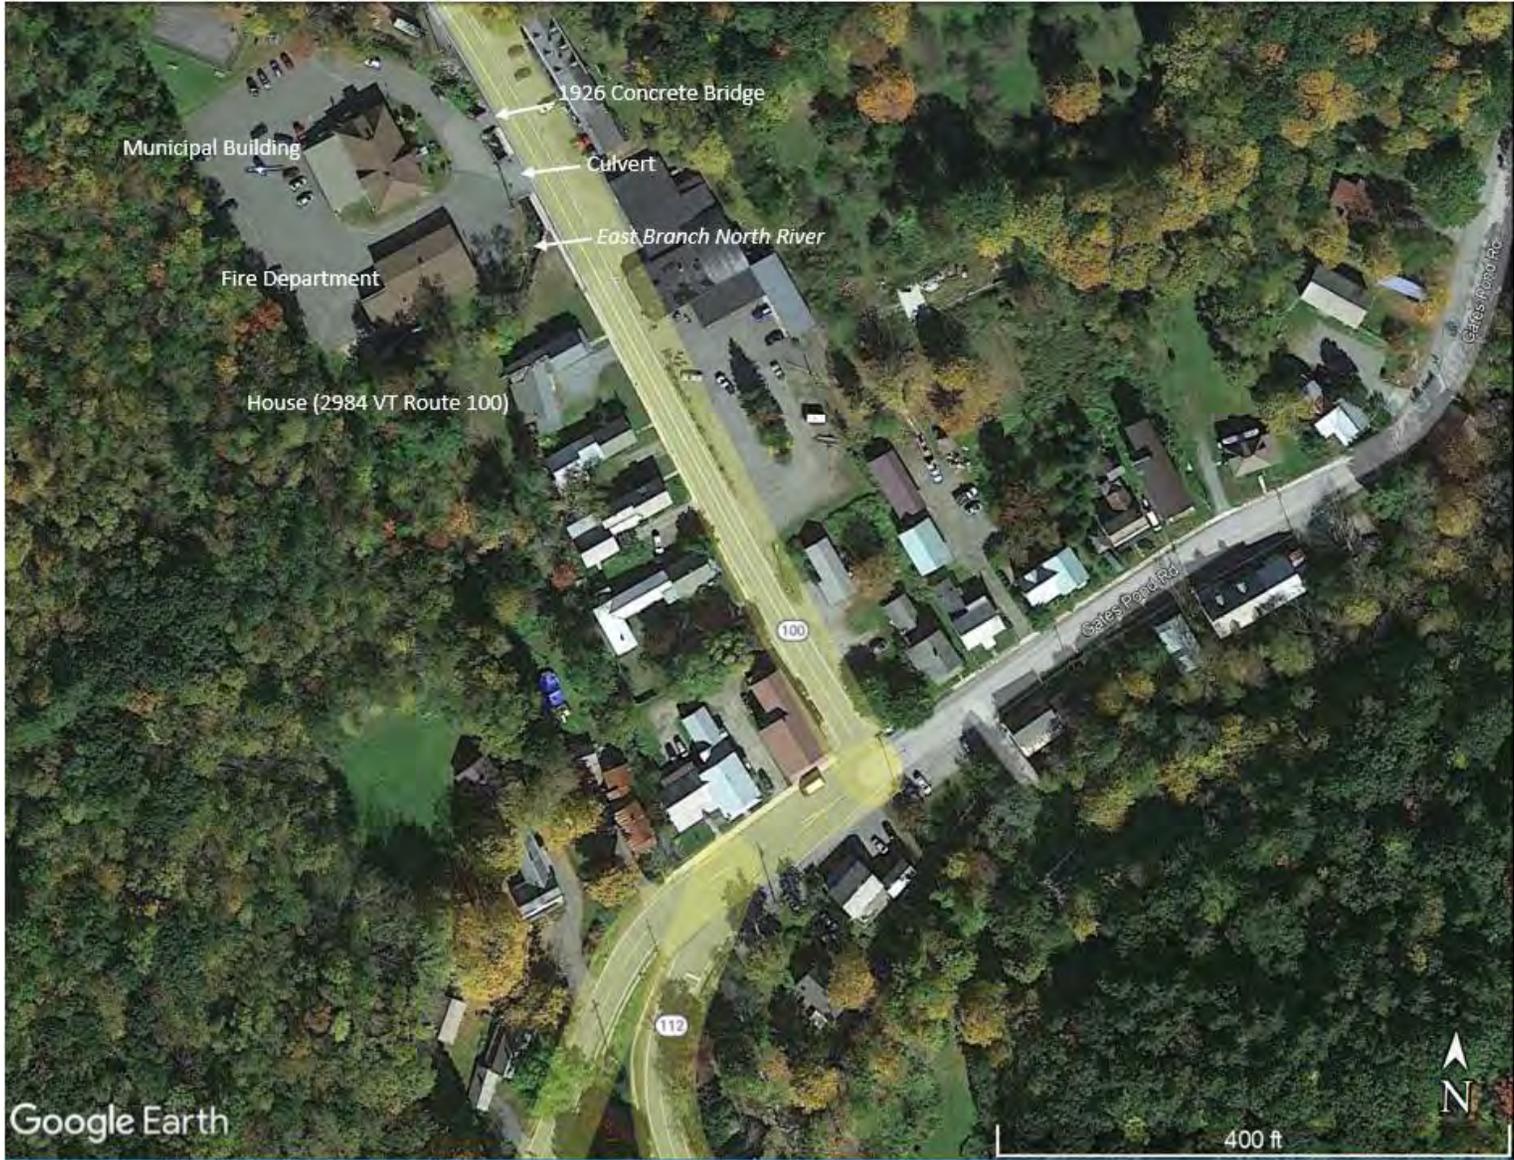
Figure 2. Map showing components of the Whitingham STP MM20(3) Flood Resiliency Project, Whitingham, Vermont.

This combined Historic Resource Review (HRR) and Archeological Resource Assessment (ARA) was prepared by the University of Vermont Consulting Archaeology Program (UVM CAP) for MSK Engineering & Design, consultants to the Town of Whitingham, to help satisfy requirements under the Section 106 permitting process for the proposed Whitingham STP MM20(3) Flood Resiliency Project, Whitingham, Windham County, Vermont (Figure 1). The Town of Whitingham is considering several undertakings to reduce the potential for flood damage within the Village of Jacksonville. The current phase of the proposed project has three potential components, all located along the west side of VT Route 100 (Figures 2 – 6):

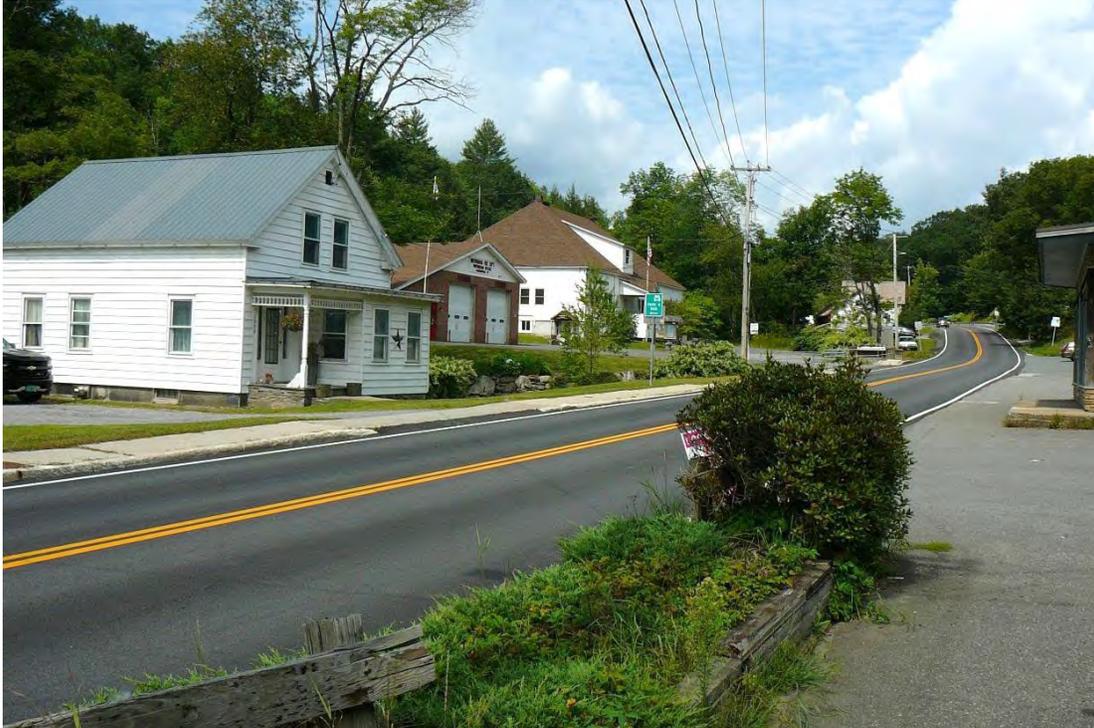
Figure 3. View northwest of the project area along VT Route 100; left to right, house at 2984 VT Route 100, fire department building, municipal building.

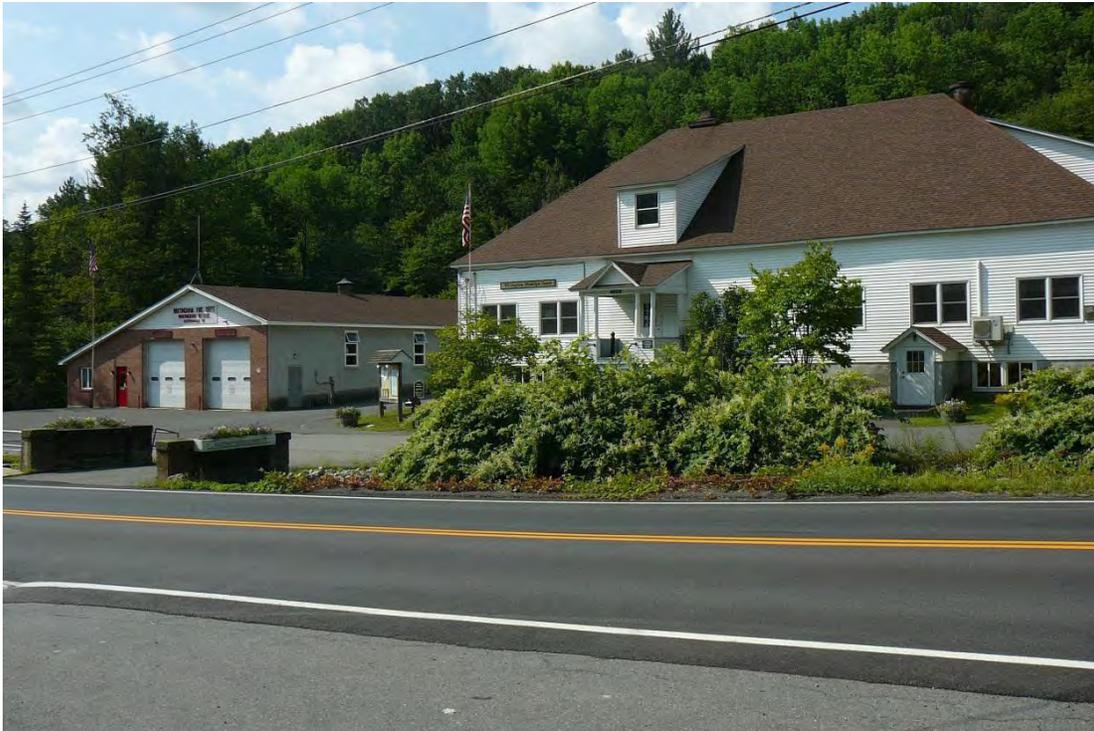
Figure 4. View southwest of the project area along VT Route 100; fire department building at left, municipal building at right, 1926 bridge at left foreground.

Constructed in 1926, the structure that crosses the East Branch of North River in front of the Municipal Center, appears to be a box culvert type concrete bridge (Figures 26 – 31; see Figure 2). The bridge crosses the river in an east-west direction. It has solid rails with centered, recessed panels on both sides, topped by a capstone, that run between two pillars with capstones. All capstones have raised centers. The height of the rail, including the capstone, is 3 ft 1 in, while the total height of the pillars, including capstones, is 3 ft 3 in, with the pillars rising 2 in above the rail. Rails are 7 ft long and the pillars measure 2 ft 1 in, for a total length of 11 ft 2 in; total length with the capstones is 11 ft 5 in. Pillars are rectangular, with their north-south length measuring 1 ft 5 in. Railings, not including the capstones, are 9 in thick. The northeast pillar has a panel with “1926” engraved on its south side. Concrete used has a rough aggregate; it was not determined if the concrete is plain or reinforced. Board form marks are evident on the substructure and the pillars. The western pillars have 1 ½ in diameter holes through them, one under the capstone and one near the base; the purpose of the holes is unknown. There are recent concrete repairs / reinforcement to the substructure. Roadway width between the pillars measures 15 ft 6 in and the traveling surface consists of asphalt over concrete. Flower boxes with “Welcome to Jacksonville” painted on their stream sides, are bolted to each rail.
