SUBMITTED TO  
**WINDHAM COUNTY REGIONAL  
COMMISSION**

SUBMITTED BY  
**MSK ENGINEERS**

SCOPING STUDY

# **Jacksonville Municipal Center Access and Flood Resiliency**

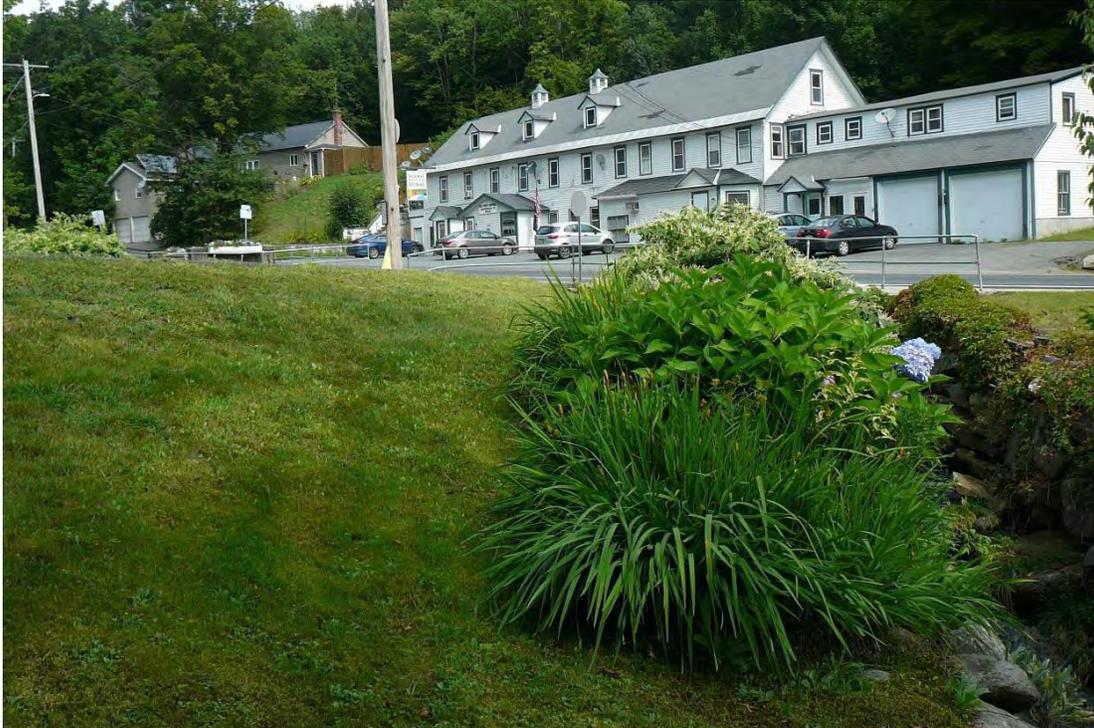
Figure 5. View northeast of the project area across VT Route 100 from in front of the fire department; East Branch North River at right corner.

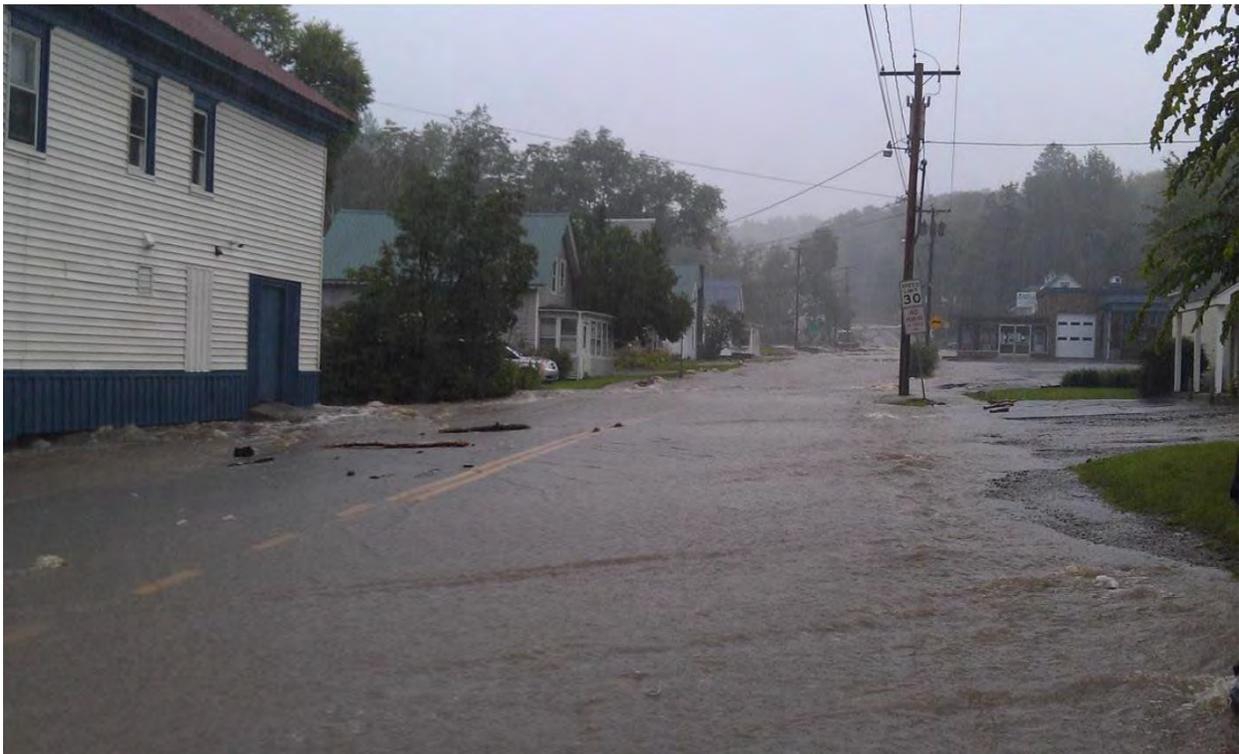
Figure 7. View northwest up Vermont Route 100 from the intersection of VT 112, during Tropical Storm Irene in 2011, with the project area in the background (Fitzgerald Environmental Associates, photo courtesy of G. Havreduk, n.d.:2).

Furthermore, near Jacksonville it was reported that the, "brooks have torn across the roads at numerous places causing washouts of varying degrees. In some instances, the worst washouts have been filled in with logs, junk & etc." (*North Adams Transcript* September 24, 1938). After the flood, it was reported that, "the town is widening and deepening the course of the river" in places (*Brattleboro Reformer* December 15, 1938). More recent severe flooding has also occurred, including during Tropical Storm Irene (Figure 7).

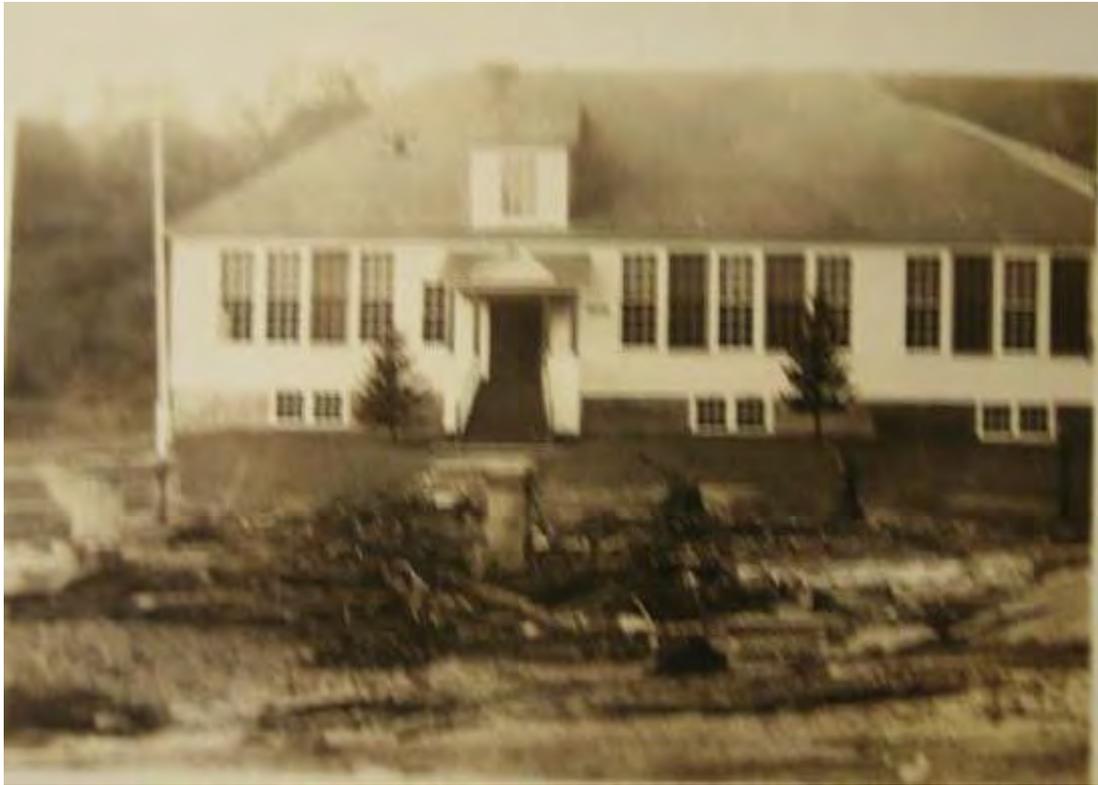
Figure 13. View southwest showing the flood damage in 1938 in front of the High School, now the Municipal Building, in Jacksonville (Bennington Museum, Bennington, Vermont. Gift of Marge Doyle, Cat No.#2004.301.7). Note that the “Welcome to Jacksonville Bridge,” built in 1926, survived the flood, but the ground around it was scoured.

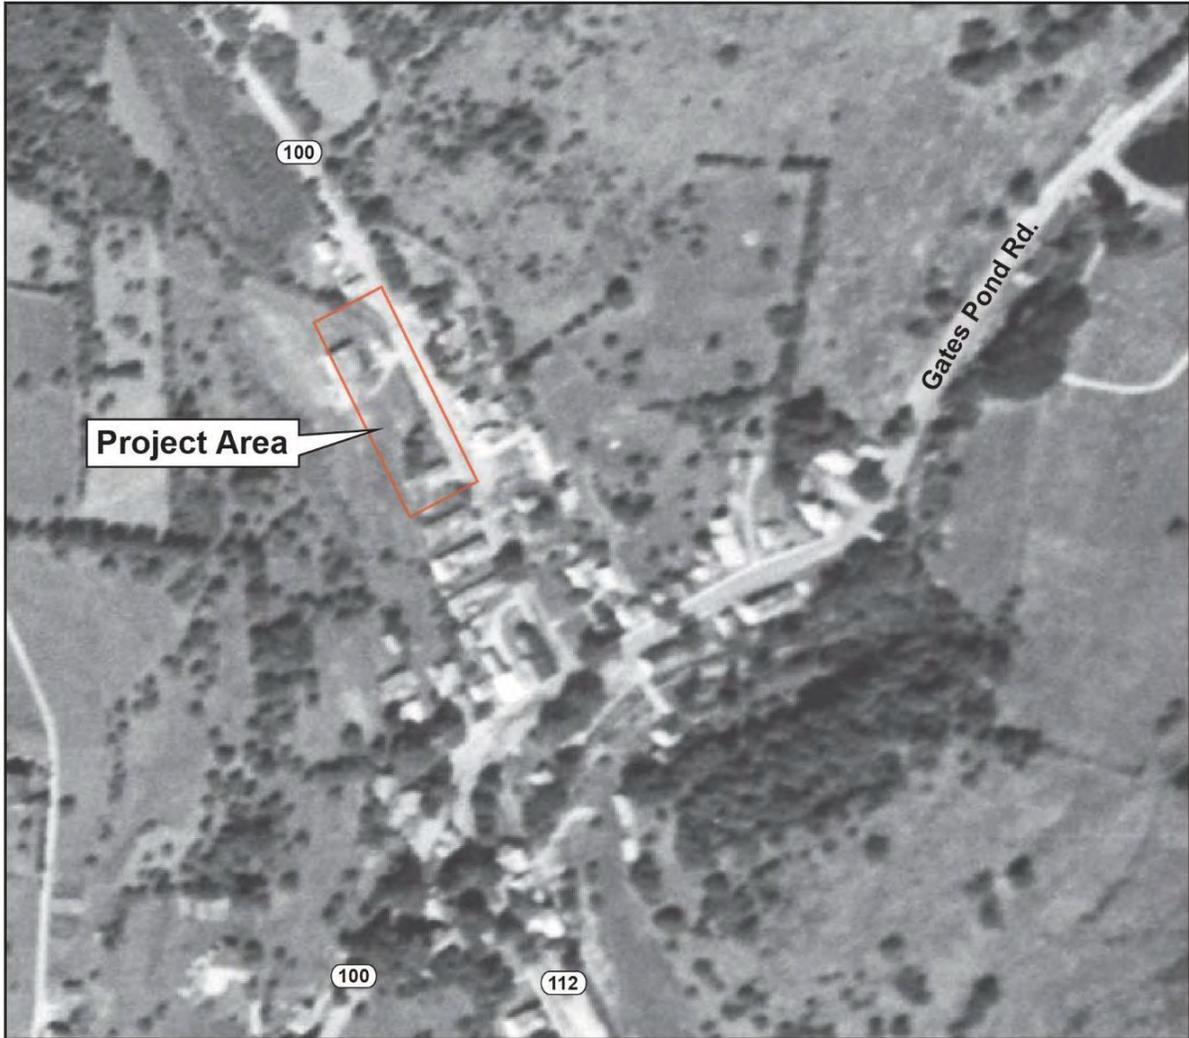
Figure 14. Detail of an aerial photograph showing the project area 1942 (Aerial Photograph GS-AE 3-85; accessed on the Vermont Center for Geographic Information's website at <https://vcgi.vermont.gov/>).

The present firehouse located south of the Municipal Center was built ca. 1973 – 1974, along with the parking lot on the north and south sides of the Municipal Center (Figures 14 and 15) (*Brattleboro Reformer* March 6, 1974). At present, the 6.1-acre municipal property also includes a triangle of land immediately north of the house at 2984 VT Route 100, where another historic period structure once stood (see Figure 11) (*Brattleboro Reformer* August 22, 1998). This structure may have been built very close to or even partially over the brook. This structure was standing in 1962 (see Figure 14) and appears to have been extant in 1993, but likely no longer existed by 2003 (Google Earth).

Historic maps indicate that no buildings were constructed within the project area until after 1856 (see Figures 8 – 10). The building that appears within the project area by 1869 is the existing house at 2984 VT Route 100 (see Figure 11). A structure that once existed immediately north of 2984 VT Route 100, is no longer extant (see Figure 11). As noted previously, this structure was standing in 1962 (see Figure 14) and appears to have been extant in 1993, but does not appear to exist by 2003 (Google Earth).

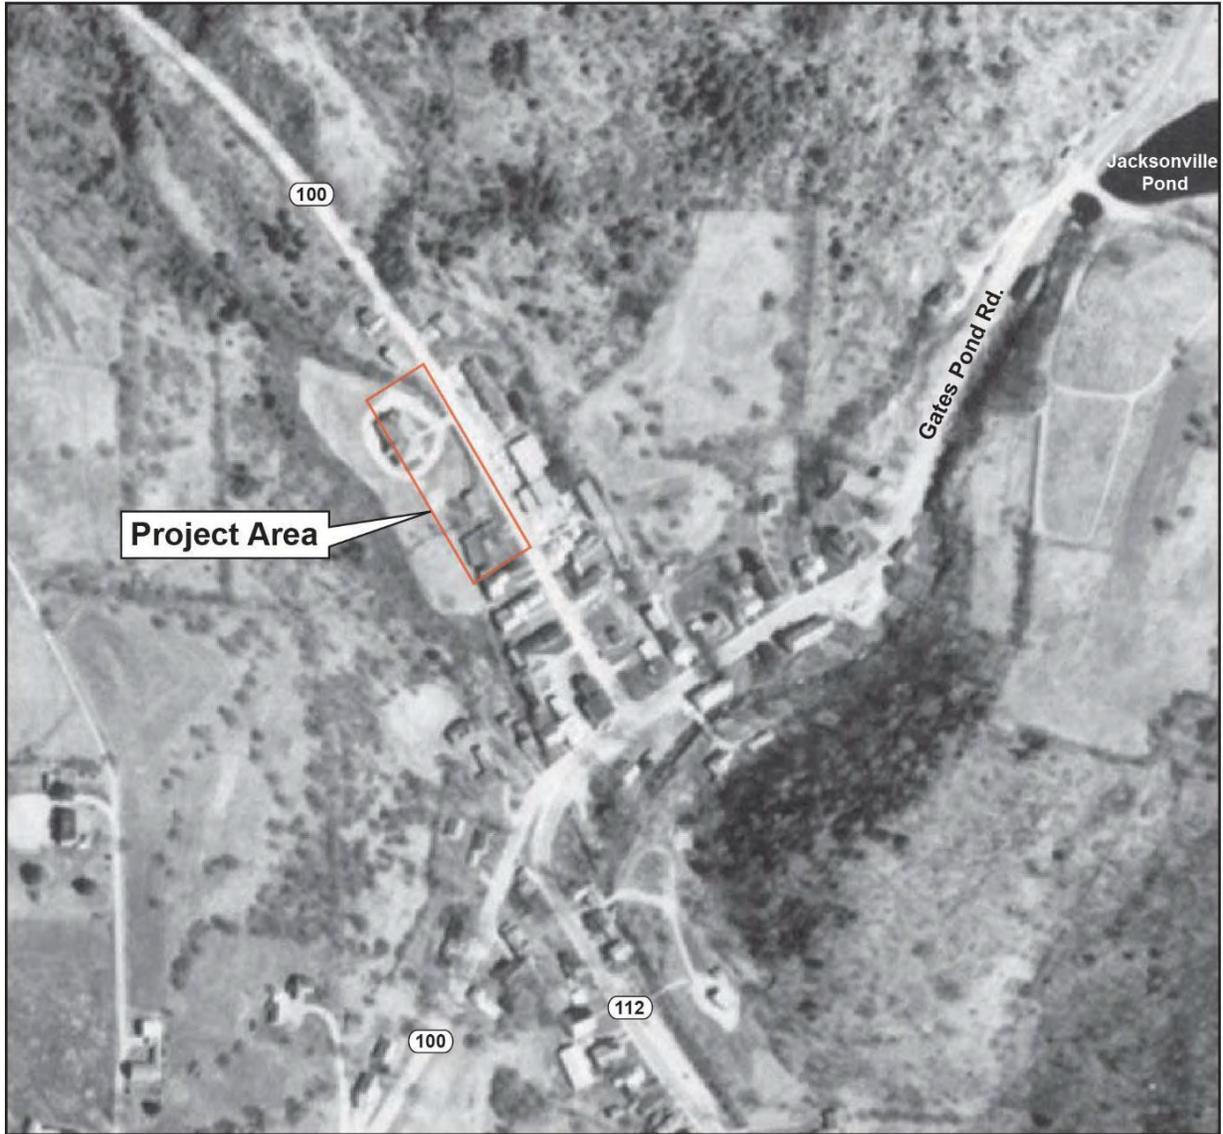
Figure 15. Detail of an aerial photograph showing the project area 1962 (Geotechnics & Resources Inc., 1962).

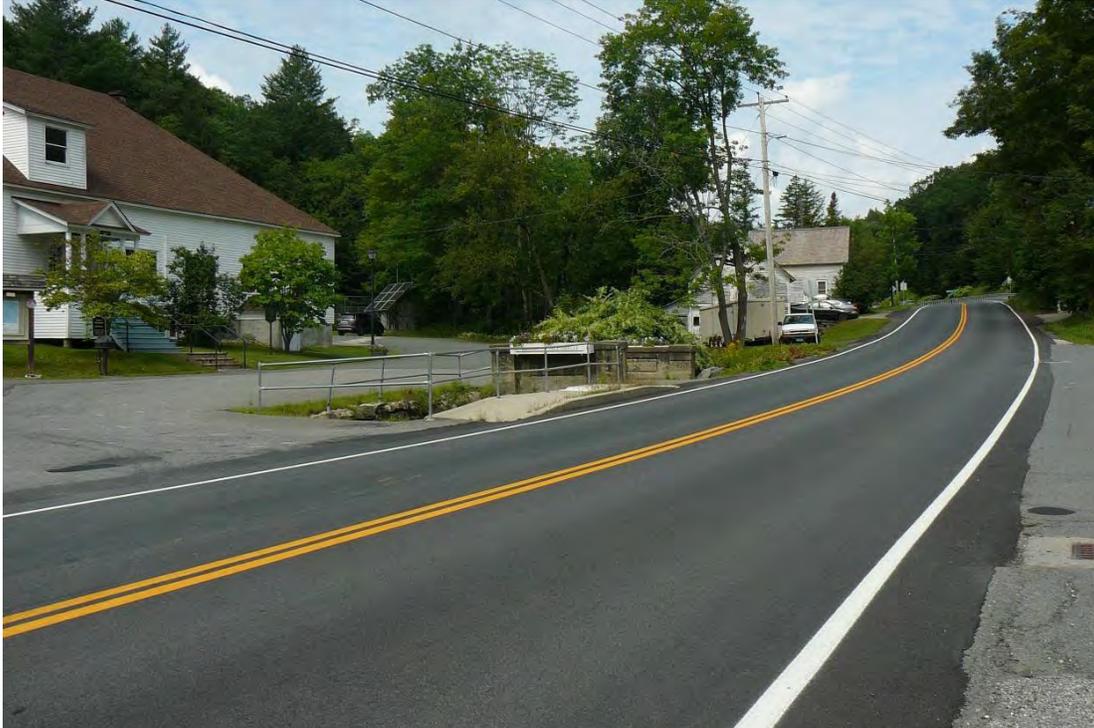
Figure 18. View northwest of the project area showing structures and paving in front of the Municipal Center.

A field inspection of the project area was conducted by Catherine A. Quinn, Historic Preservation Specialist at the UVM CAP, on August 27, 2021. The general project area is primarily built upon with VT Route 100, a concrete sidewalk, the Municipal Center and surrounding paved parking areas, the concrete bridge, the metal culvert, and the house and its attached structures (Figures 18 – 23). Riverbanks within the project area are lined/reinforced with concrete and stone (Figures 24 and 25).

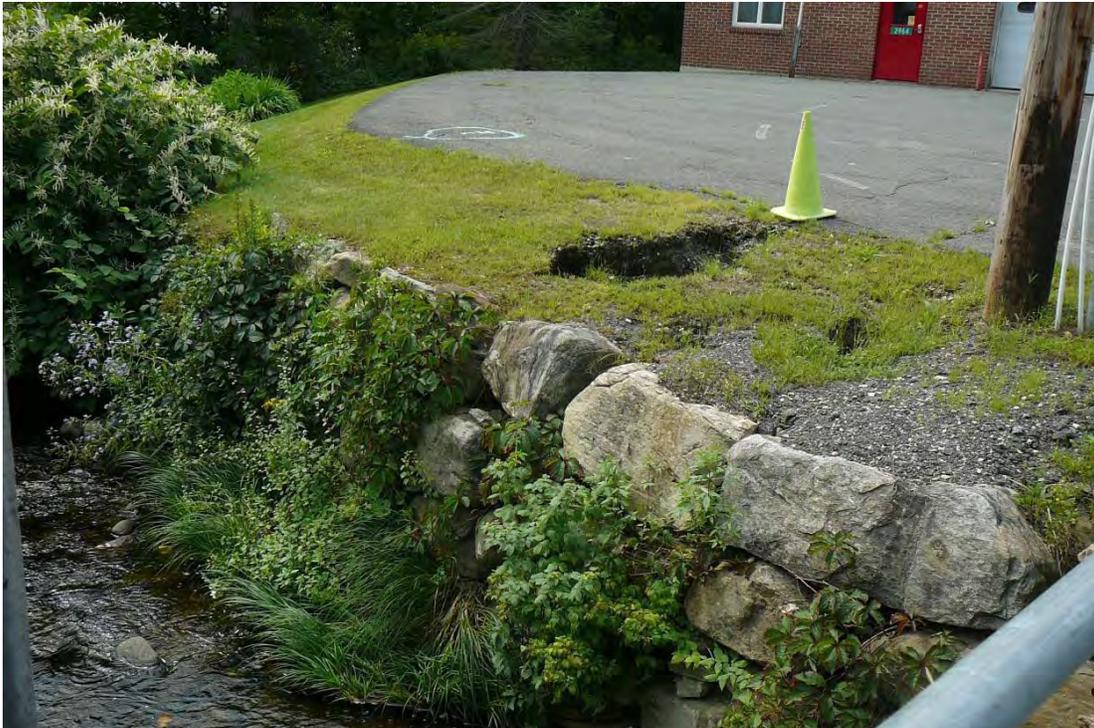
Figure 19. View southwest of the project area showing fill, utility pole and paving in front of the Fire House.

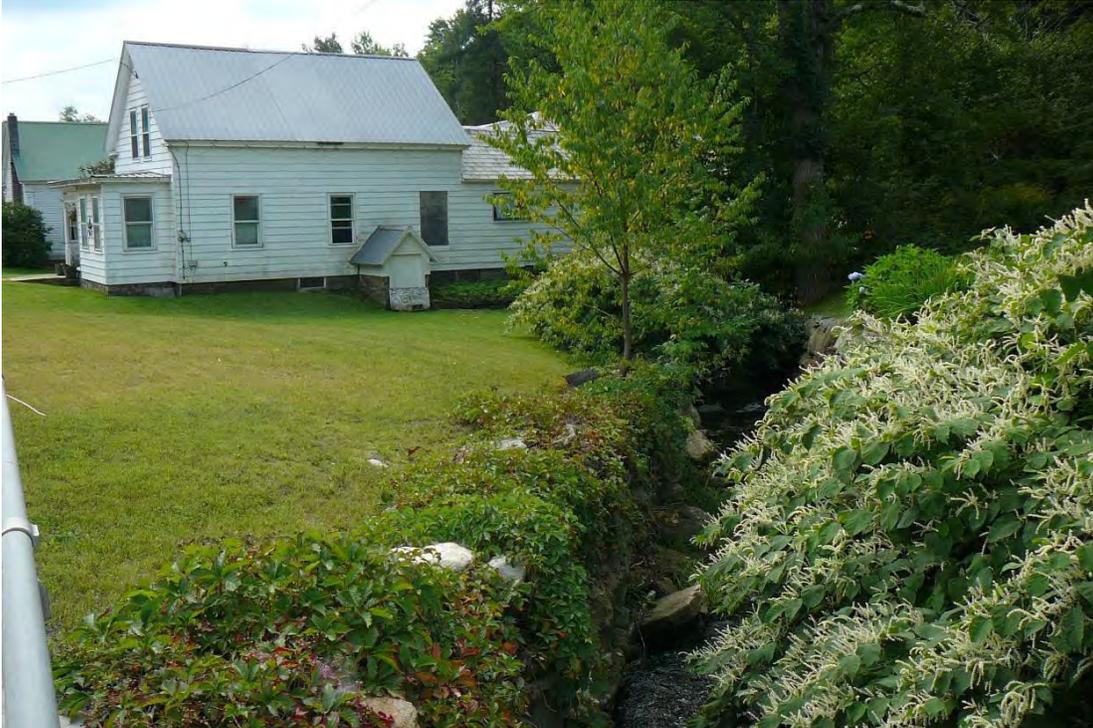
Figure 20. View southwest of the project area showing area of fill to the north of house at 2984 VT Route 100.

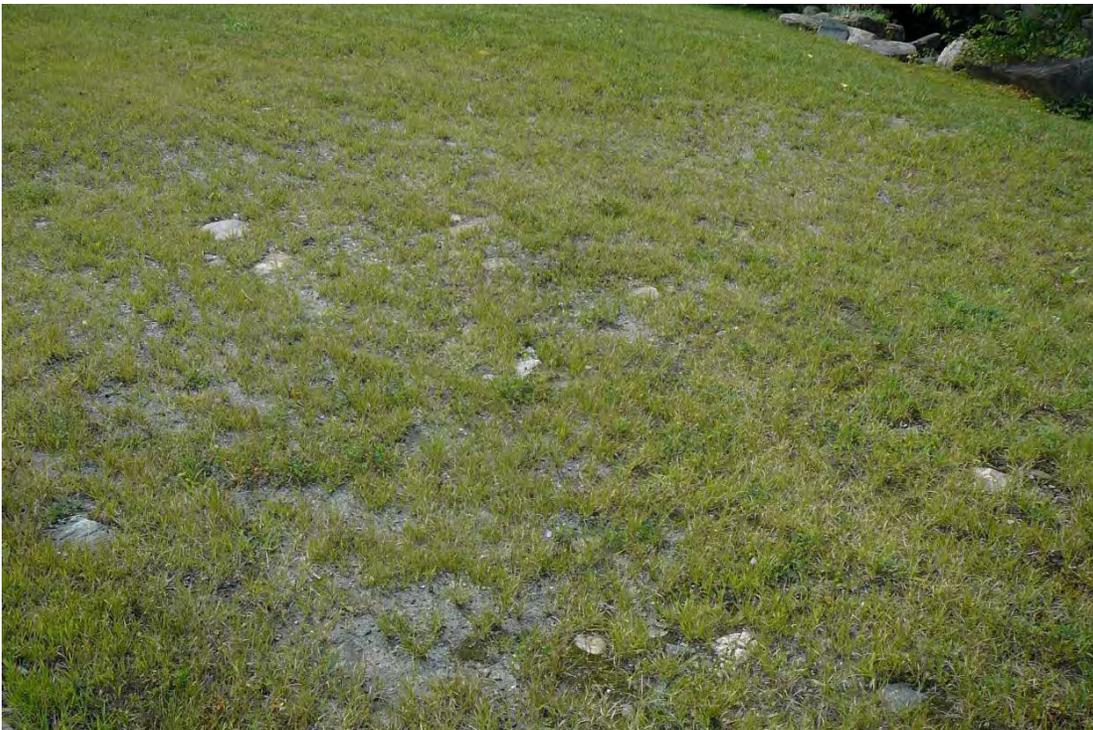
Figure 21. Close-up view southwest of fill to the north of house at 2984 VT Route 100.

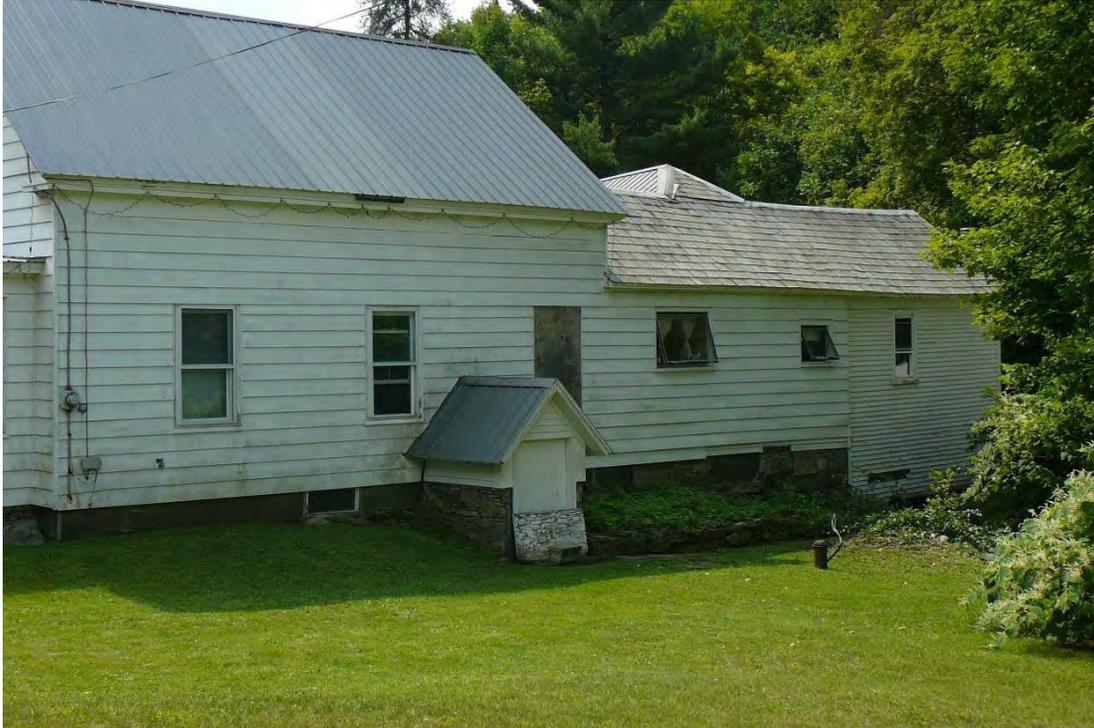
Figure 22. View southwest of the project area showing well location to the north of house at 2984 VT Route 100.

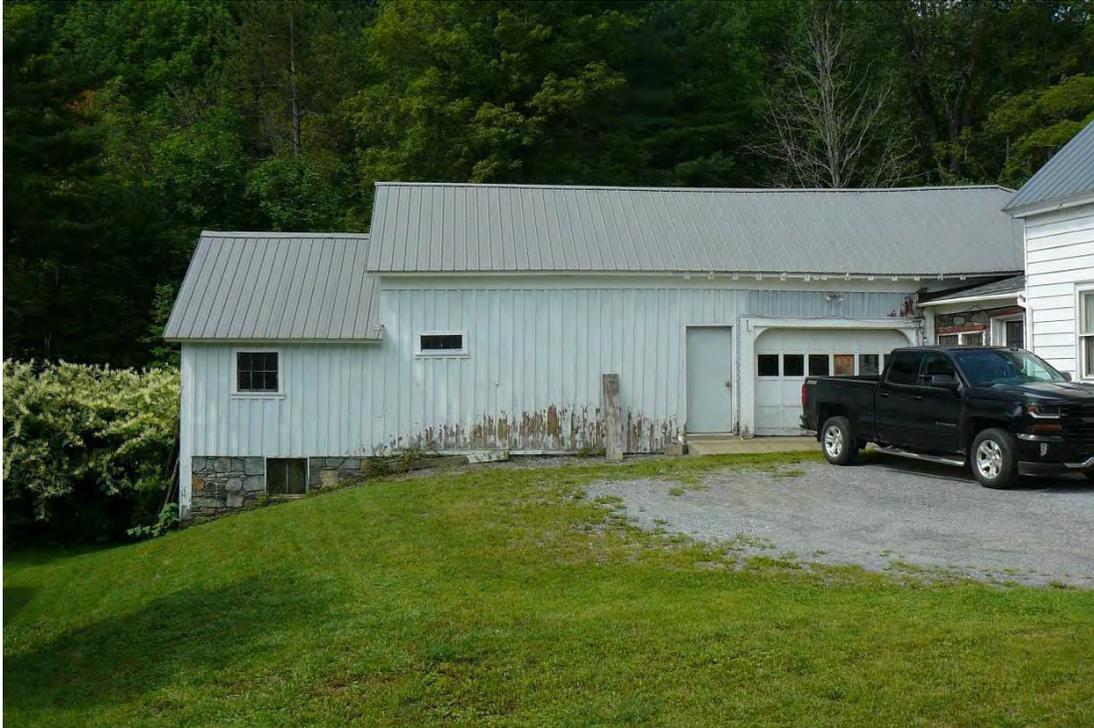
Figure 23. View west of the project area showing area of probable fill/land disturbance to the east of house at 2984 VT Route 100.

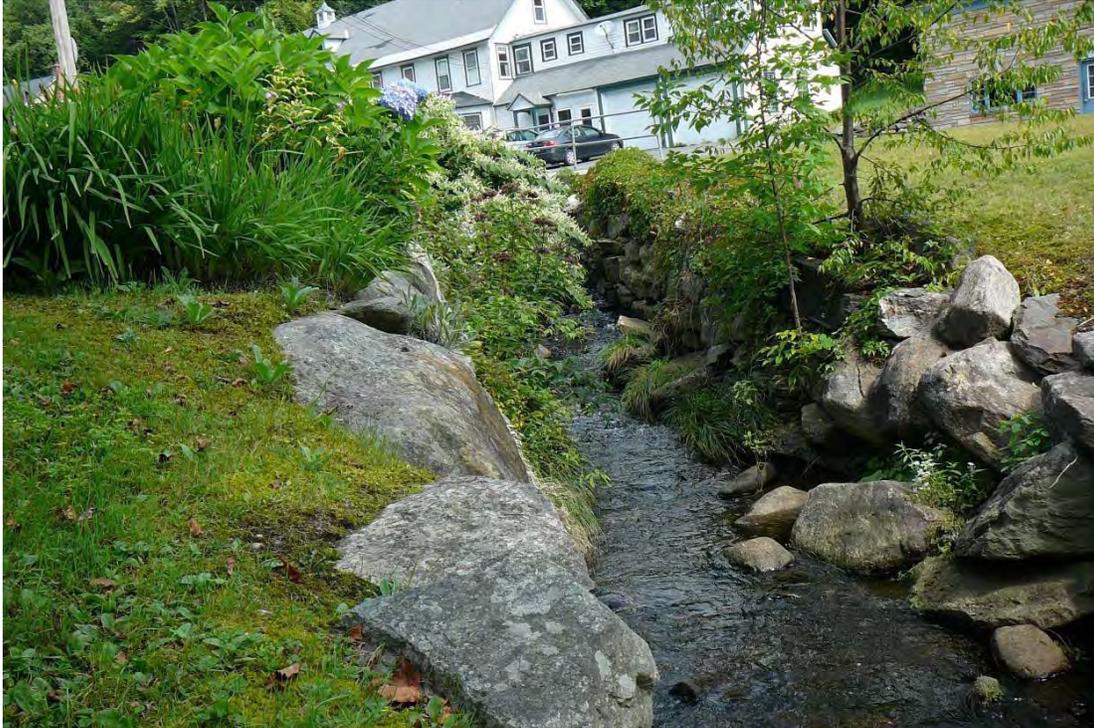
Figure 24. View northeast of riverbanks within the project area; fire station is to left and house at 2984 VT Route 100 is to right.

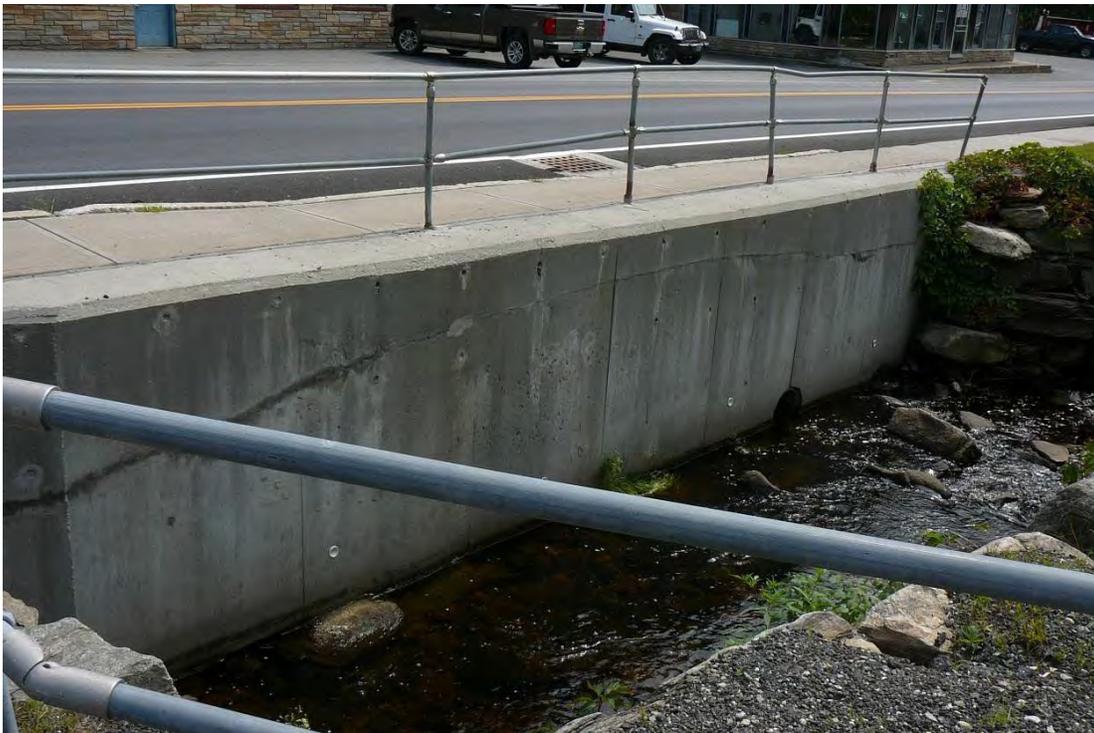
Figure 25. View southeast of concrete riverbank wall along VT Route 100 within the project area, between the concrete bridge and culver.

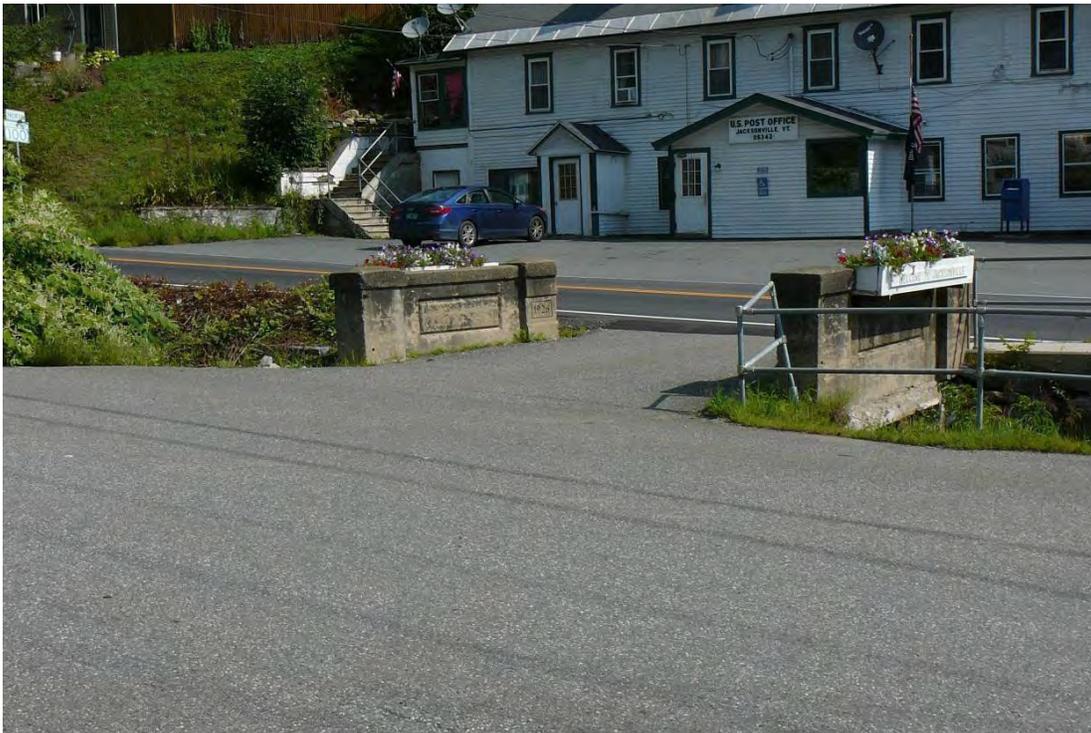
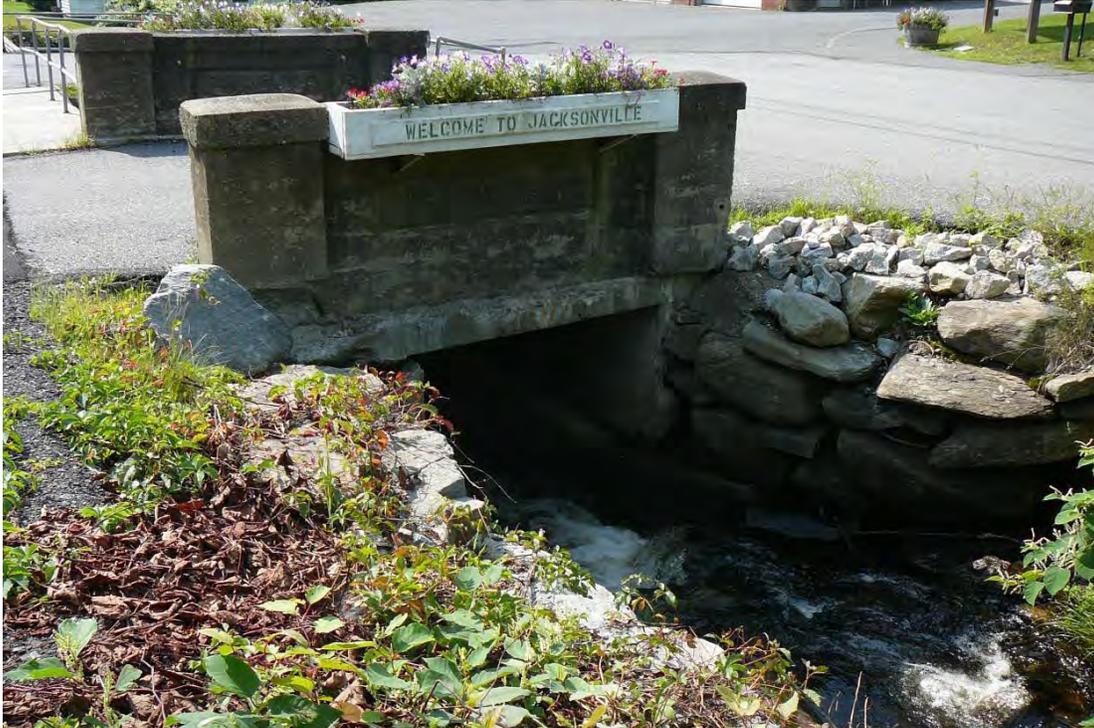
Figure 26. View northeast of concrete bridge.

Figure 27. View northeast of concrete bridge.

Constructed in 1926, the structure that crosses the East Branch of North River in front of the Municipal Center, appears to be a box culvert type concrete bridge (Figures 26 – 31; see Figure 2). The bridge crosses the river in an east-west direction. It has solid rails with centered, recessed panels on both sides, topped by a capstone, that run between two pillars with capstones. All capstones have raised centers. The height of the rail, including the capstone, is 3 ft 1 in, while the total height of the pillars, including capstones, is 3 ft 3 in, with the pillars rising 2 in above the rail. Rails are 7 ft long and the pillars measure 2 ft 1 in, for a total length of 11 ft 2 in; total length with the capstones is 11 ft 5 in. Pillars are rectangular, with their north-south length measuring 1 ft 5 in. Railings, not including the capstones, are 9 in thick. The northeast pillar has a panel with “1926” engraved on its south side. Concrete used has a rough aggregate; it was not determined if the concrete is plain or reinforced. Board form marks are evident on the substructure and the pillars. The western pillars have 1 ½ in diameter holes through them, one under the capstone and one near the base; the purpose of the holes is unknown. There are recent concrete repairs / reinforcement to the substructure. Roadway width between the pillars measures 15 ft 6 in and the traveling surface consists of asphalt over concrete. Flower boxes with “Welcome to Jacksonville” painted on their stream sides, are bolted to each rail.

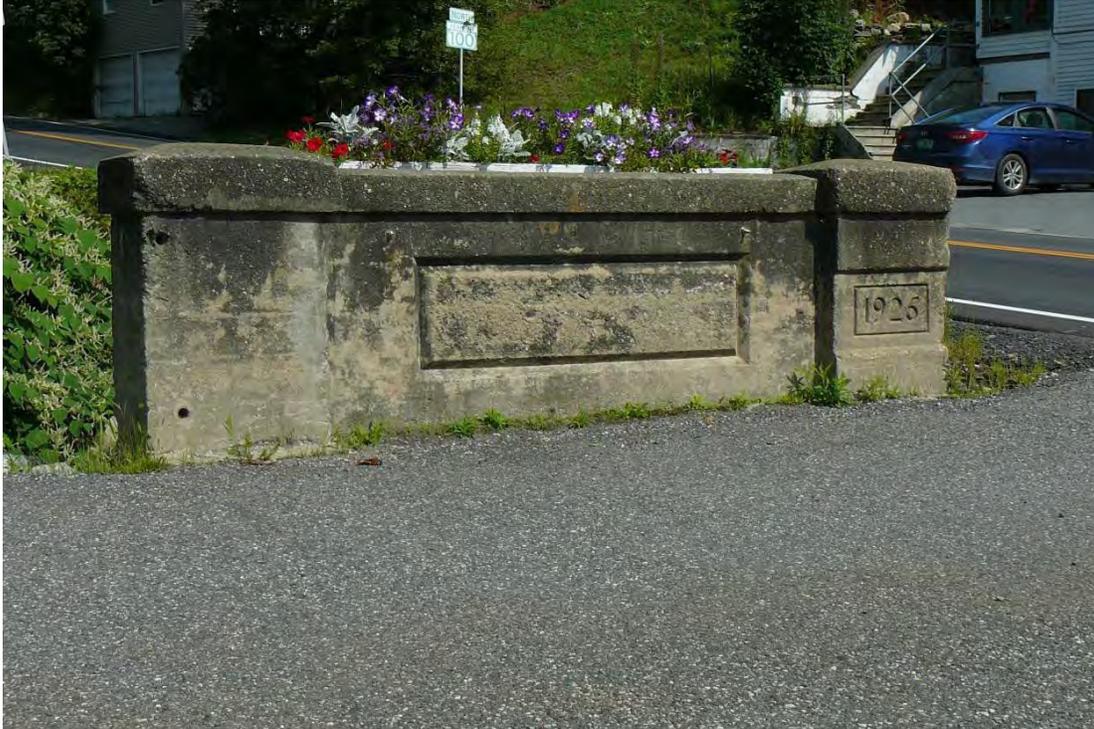
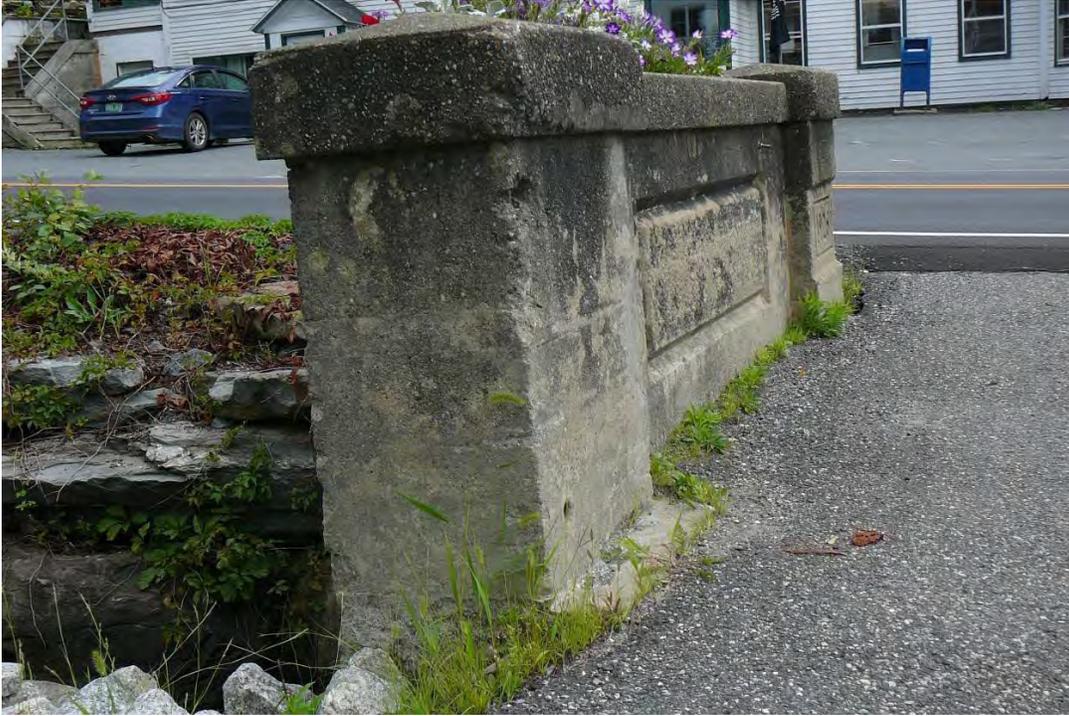
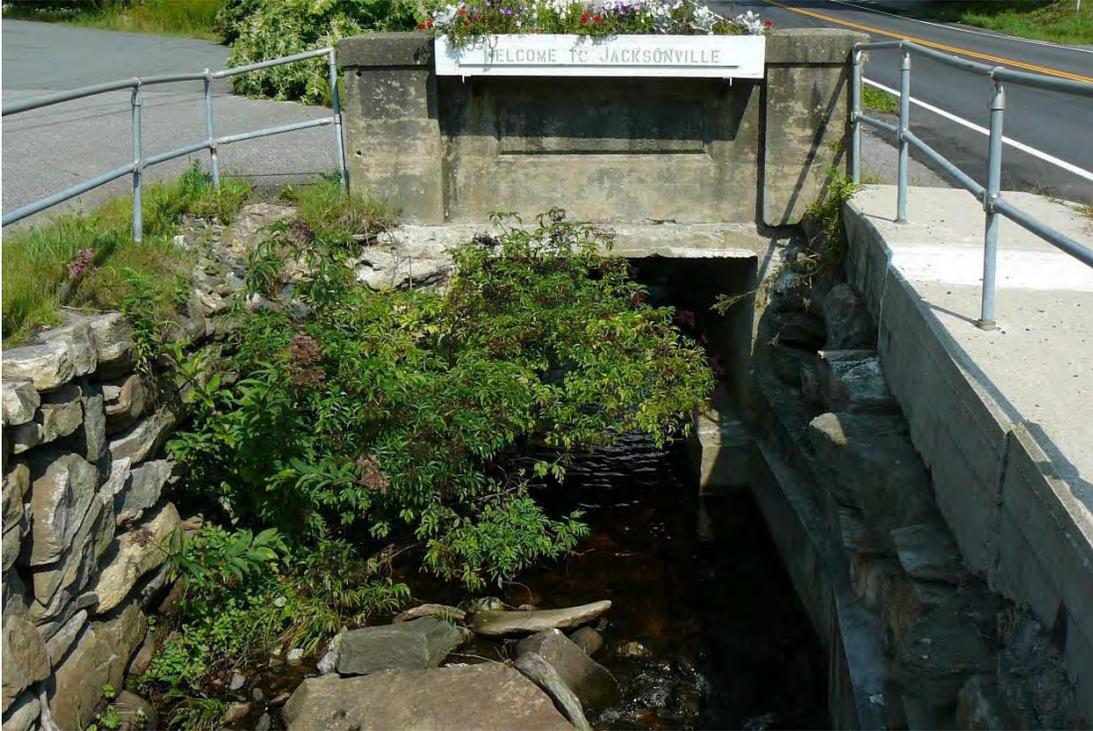
Figure 28. View northeast of upstream rail of concrete bridge.

Figure 29. View northeast of upstream rail of concrete bridge.

Figure 30. View northwest of downstream rail of concrete bridge.

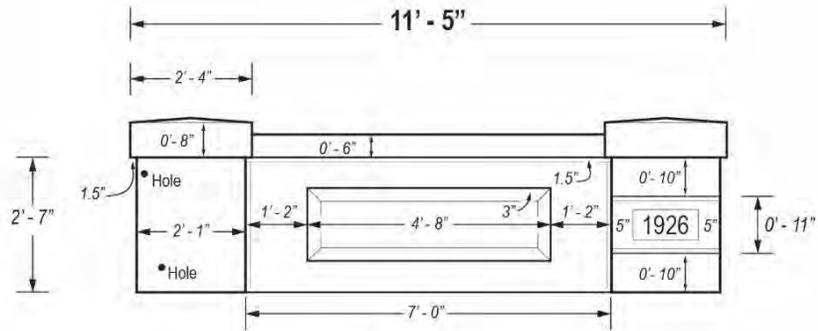
# Whitingham Bridge Detail

## Elevation

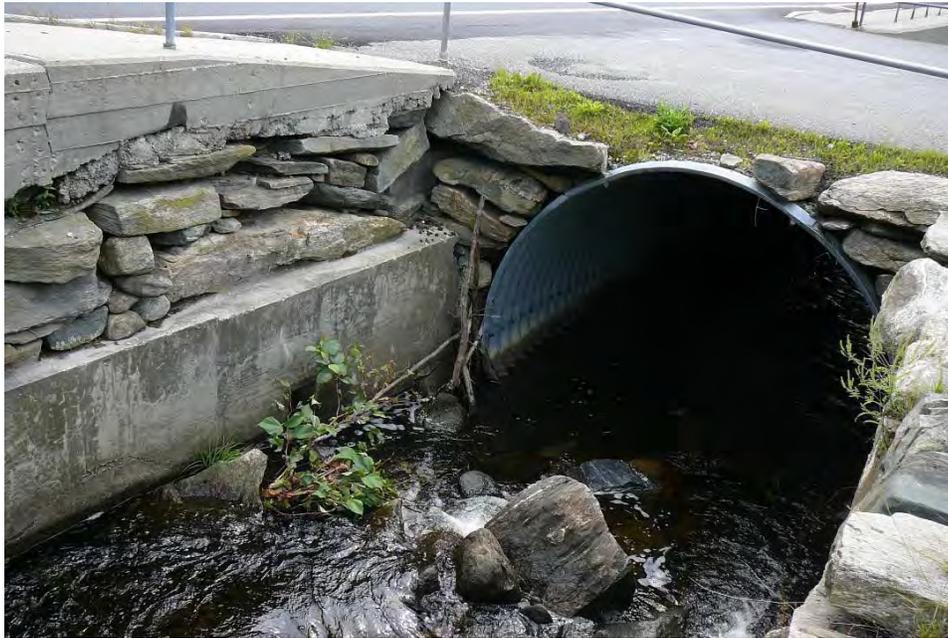
Figure 32. View southeast of inlet/upstream end of culvert.

A structure under the southern entrance to the Municipal Center consists of an 8.5 ft wide squash Corrugated Metal Pipe (CMP) type culvert (Fitzgerald Environmental Associates 2017, Table 5.4) (Figures 32 and 33; see Figure 2). The CMP carries the East Branch of North River under the roadway, south of the concrete bridge. It is surrounded by rock and fill, and the road surface above it is paved.

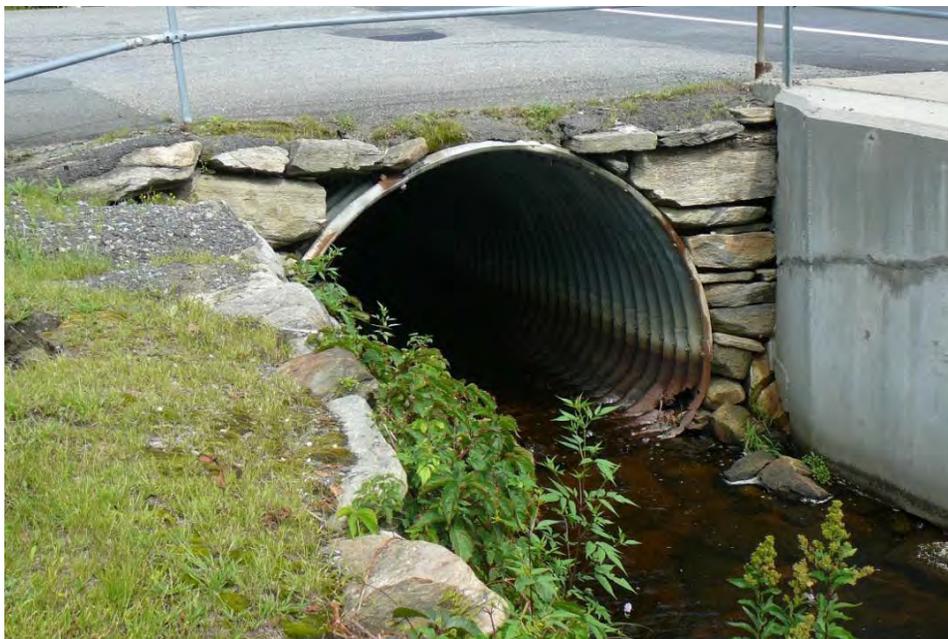
Figure 33. View northeast of outlet/downstream end of culvert.

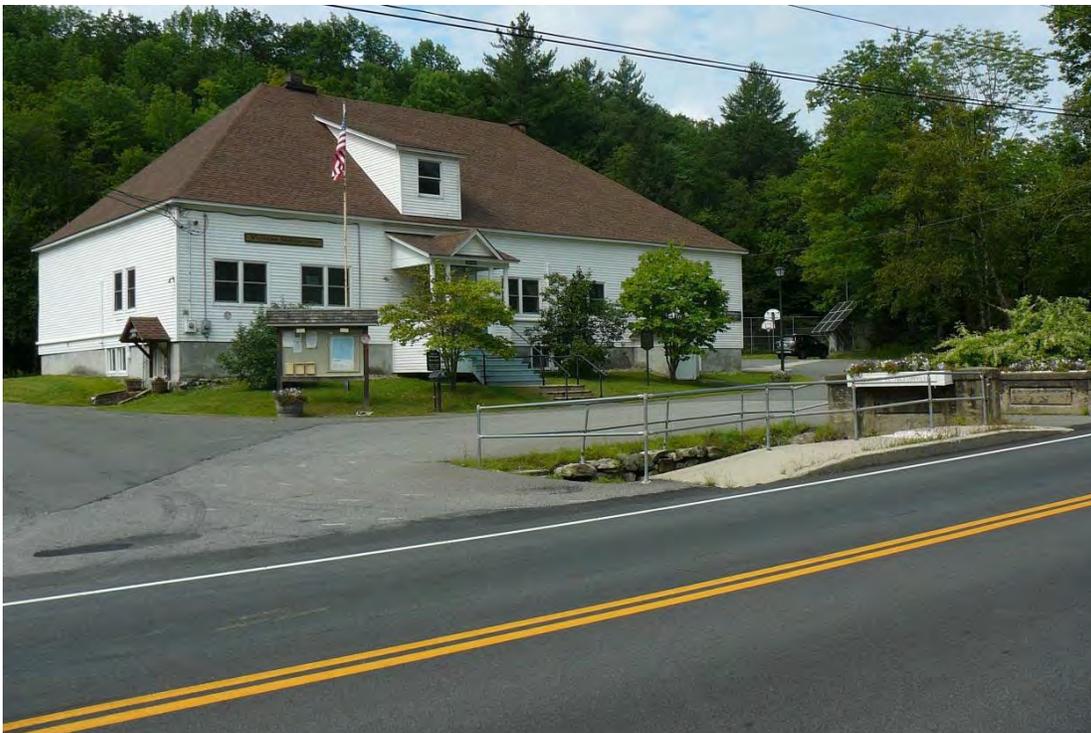
Figure 34. View northwest of the Municipal Center.

Constructed in 1927 as a high school and renovated to town offices in 1960 – 1961, the Municipal Center at 2948 VT Route 100 is a single story, rectangular building with steeply sloped hipped roof, concrete foundation, and rear wing addition (Figure 34). The primary entrance is on the east side of the building and a small porch with four columns covers the entry door. Concrete and wooden steps lead up to the porch. There are various other entrances around the building. Shed dormers are in place on the east, west and north roof slopes. It is clad in vinyl or aluminum siding and has asphalt shingle roofing. Windows on the building have been significantly altered since its use as a school (see Figure 13).

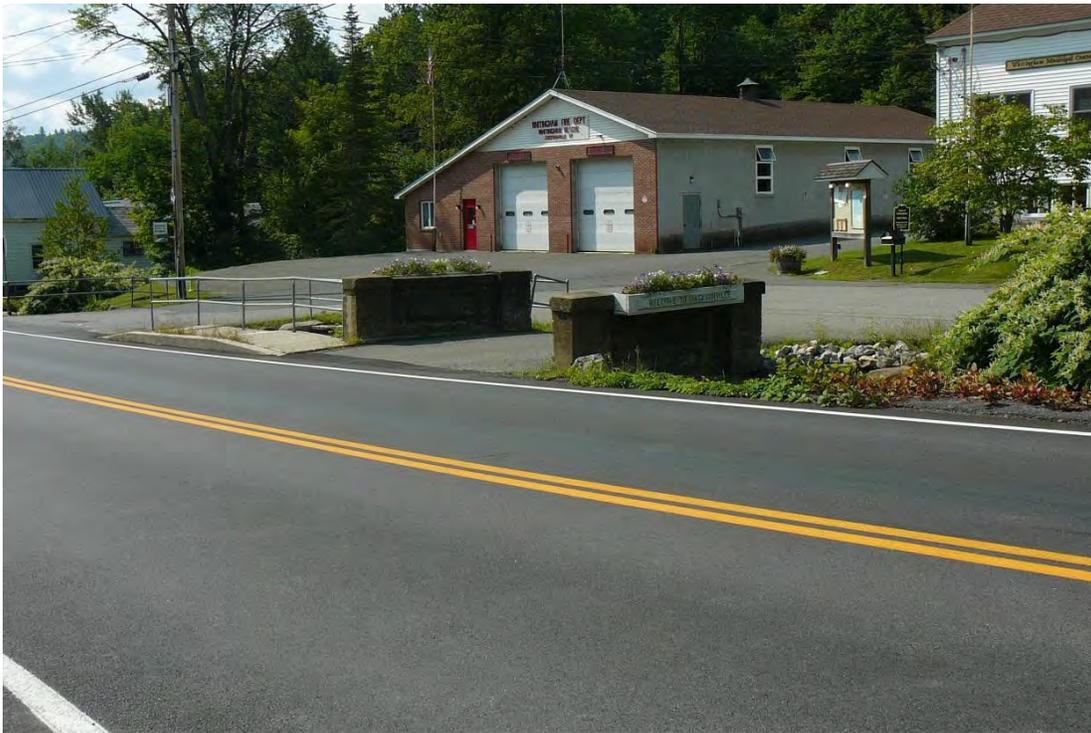
Figure 35. View southwest of the firehouse.

Constructed c. 1974, the firehouse at 2964 VT Route 100 is a rectangular, concrete building with an irregular sloped gable roof with asphalt shingles (Figure 35). The gable end faces VT Route 100. It has brick facing on its front (east) side, two overhead doors for firetrucks, and an entrance door. Windows are in place on the south and north sides of the building.
