SUBMITTED TO  
**WINDHAM COUNTY REGIONAL  
COMMISSION**

SUBMITTED BY  
**MSK ENGINEERS**

SCOPING STUDY

# **Jacksonville Municipal Center Access and Flood Resiliency**

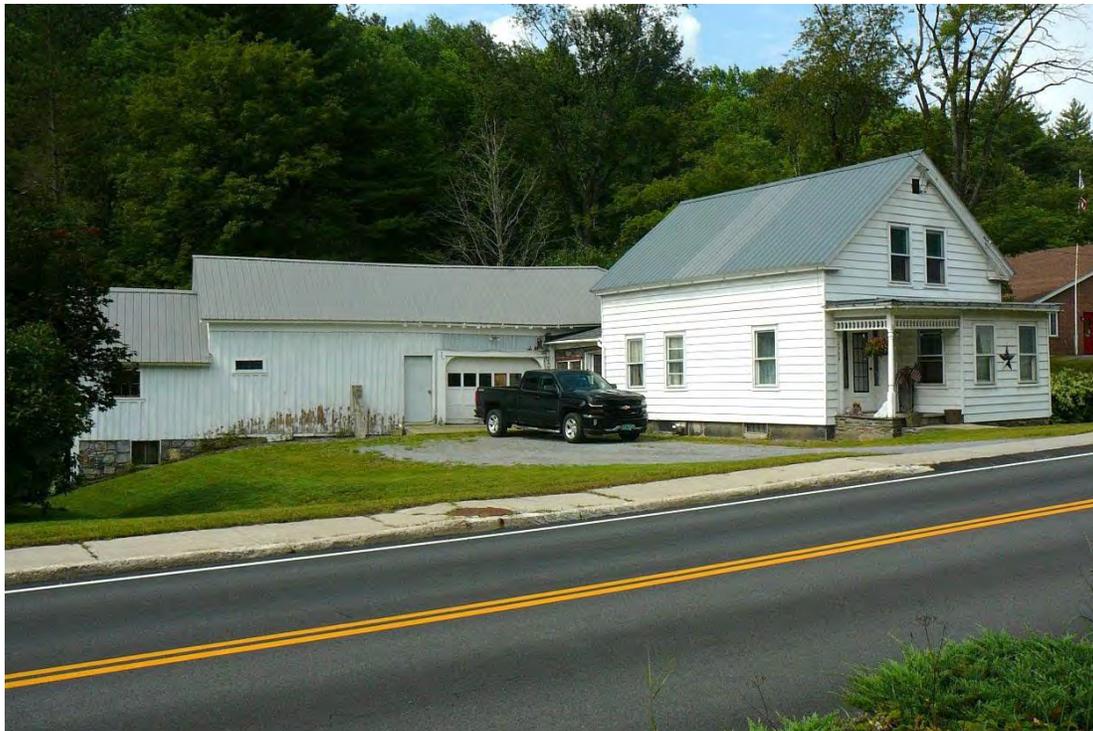
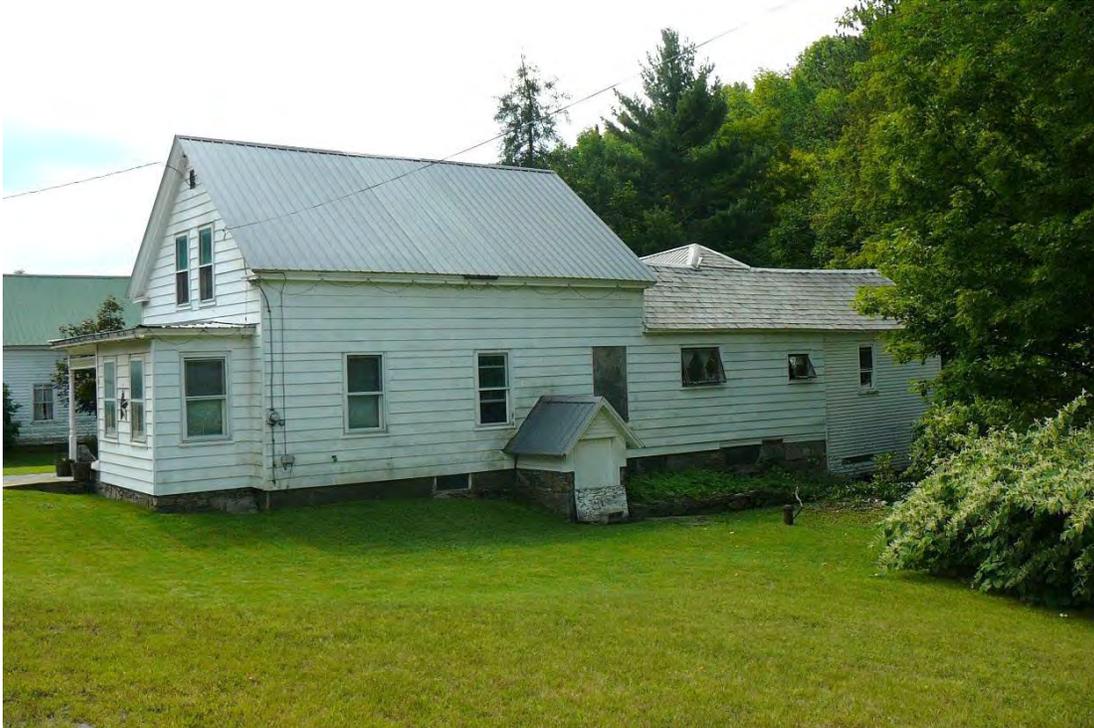
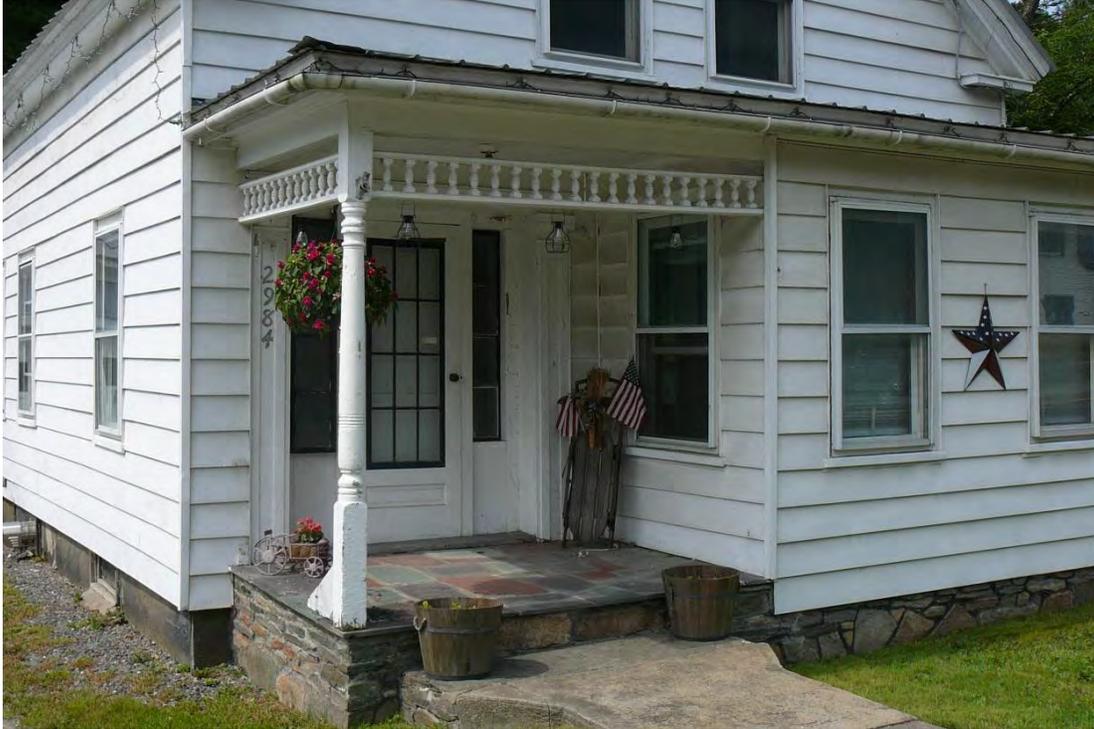
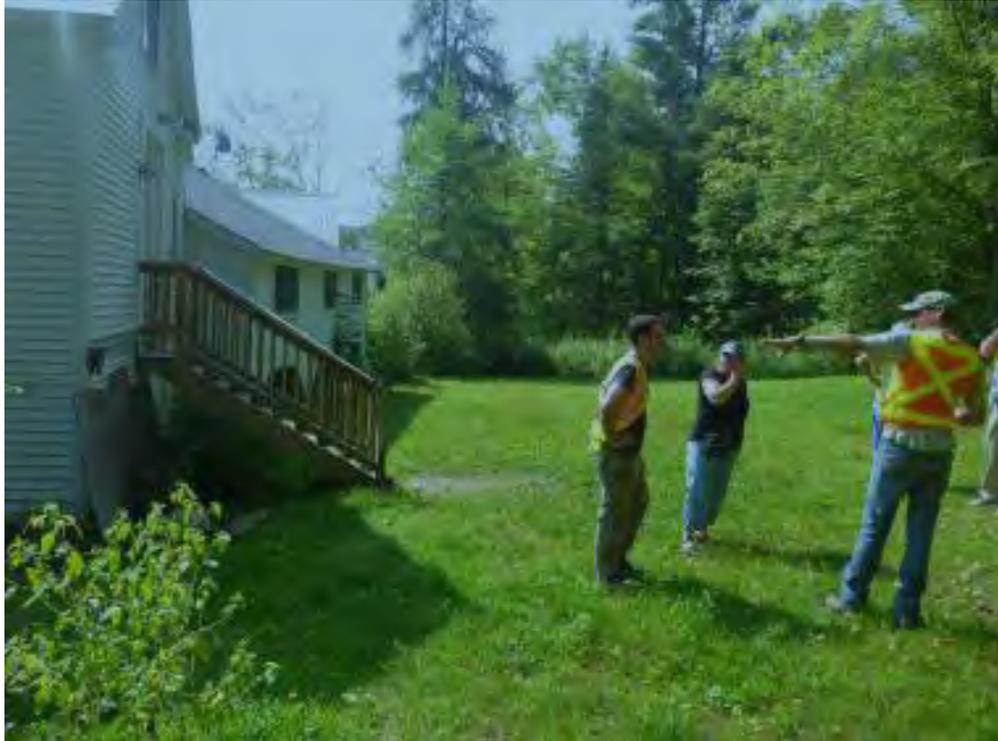
Figure 36. View northwest of the house at 2984 VT Route 100.

Figure 37. View southwest of the house at 2984 VT Route 100.

Figure 38. View northwest of the porch on the house at 2984 VT Route 100.

Figure 39. View southeast of the rear (west) side of the house at 2984 VT Route 100. (Fitzgerald Environmental Associates n.d.:9).

Constructed c. 1860, 2984 VT Route 100 is a 1 ½ story gable front house with an attached single story wing on its west (rear) side, which then attaches to a perpendicular running barn (Figures 36 – 38). The building is situated on the west side of VT Route 100, on the east bank of the East Branch of the North River, with the ell and barn extending over the river and resting on the west bank. The structures rest on a concrete or concrete-faced foundation, with some portions of the foundation having a stone veneer. Roofs on the main block and barn are metal, while the ell has a slate roof. The house and easternmost portion of the ell, area clad in wide aluminum siding and the portion of the ell that extends over the river has clapboard siding. The barn has wood siding with vertical batten strips. An overhead garage door has been added to the east elevation of the barn, and it also has an entry door. Windows on the house are 1/1 double hung sash. The ell has awning and 1/1 windows. A small gable roof structure appears to provide entry to the basement on the north side of the house. The main entrance door at the southeast corner of the house is flanked by multi-pane sidelights. A small Queen Anne style porch with a turned post and spindle work board protect the entryway. The northern half of the porch area has been enclosed since the early 1900s (see Figure 11 and 12).
